# POLYGUARD RD-6

**“A FAIL SAFE” PIPELINE**

**COATING SYSTEM**

**FOR REHABILITATION OR**

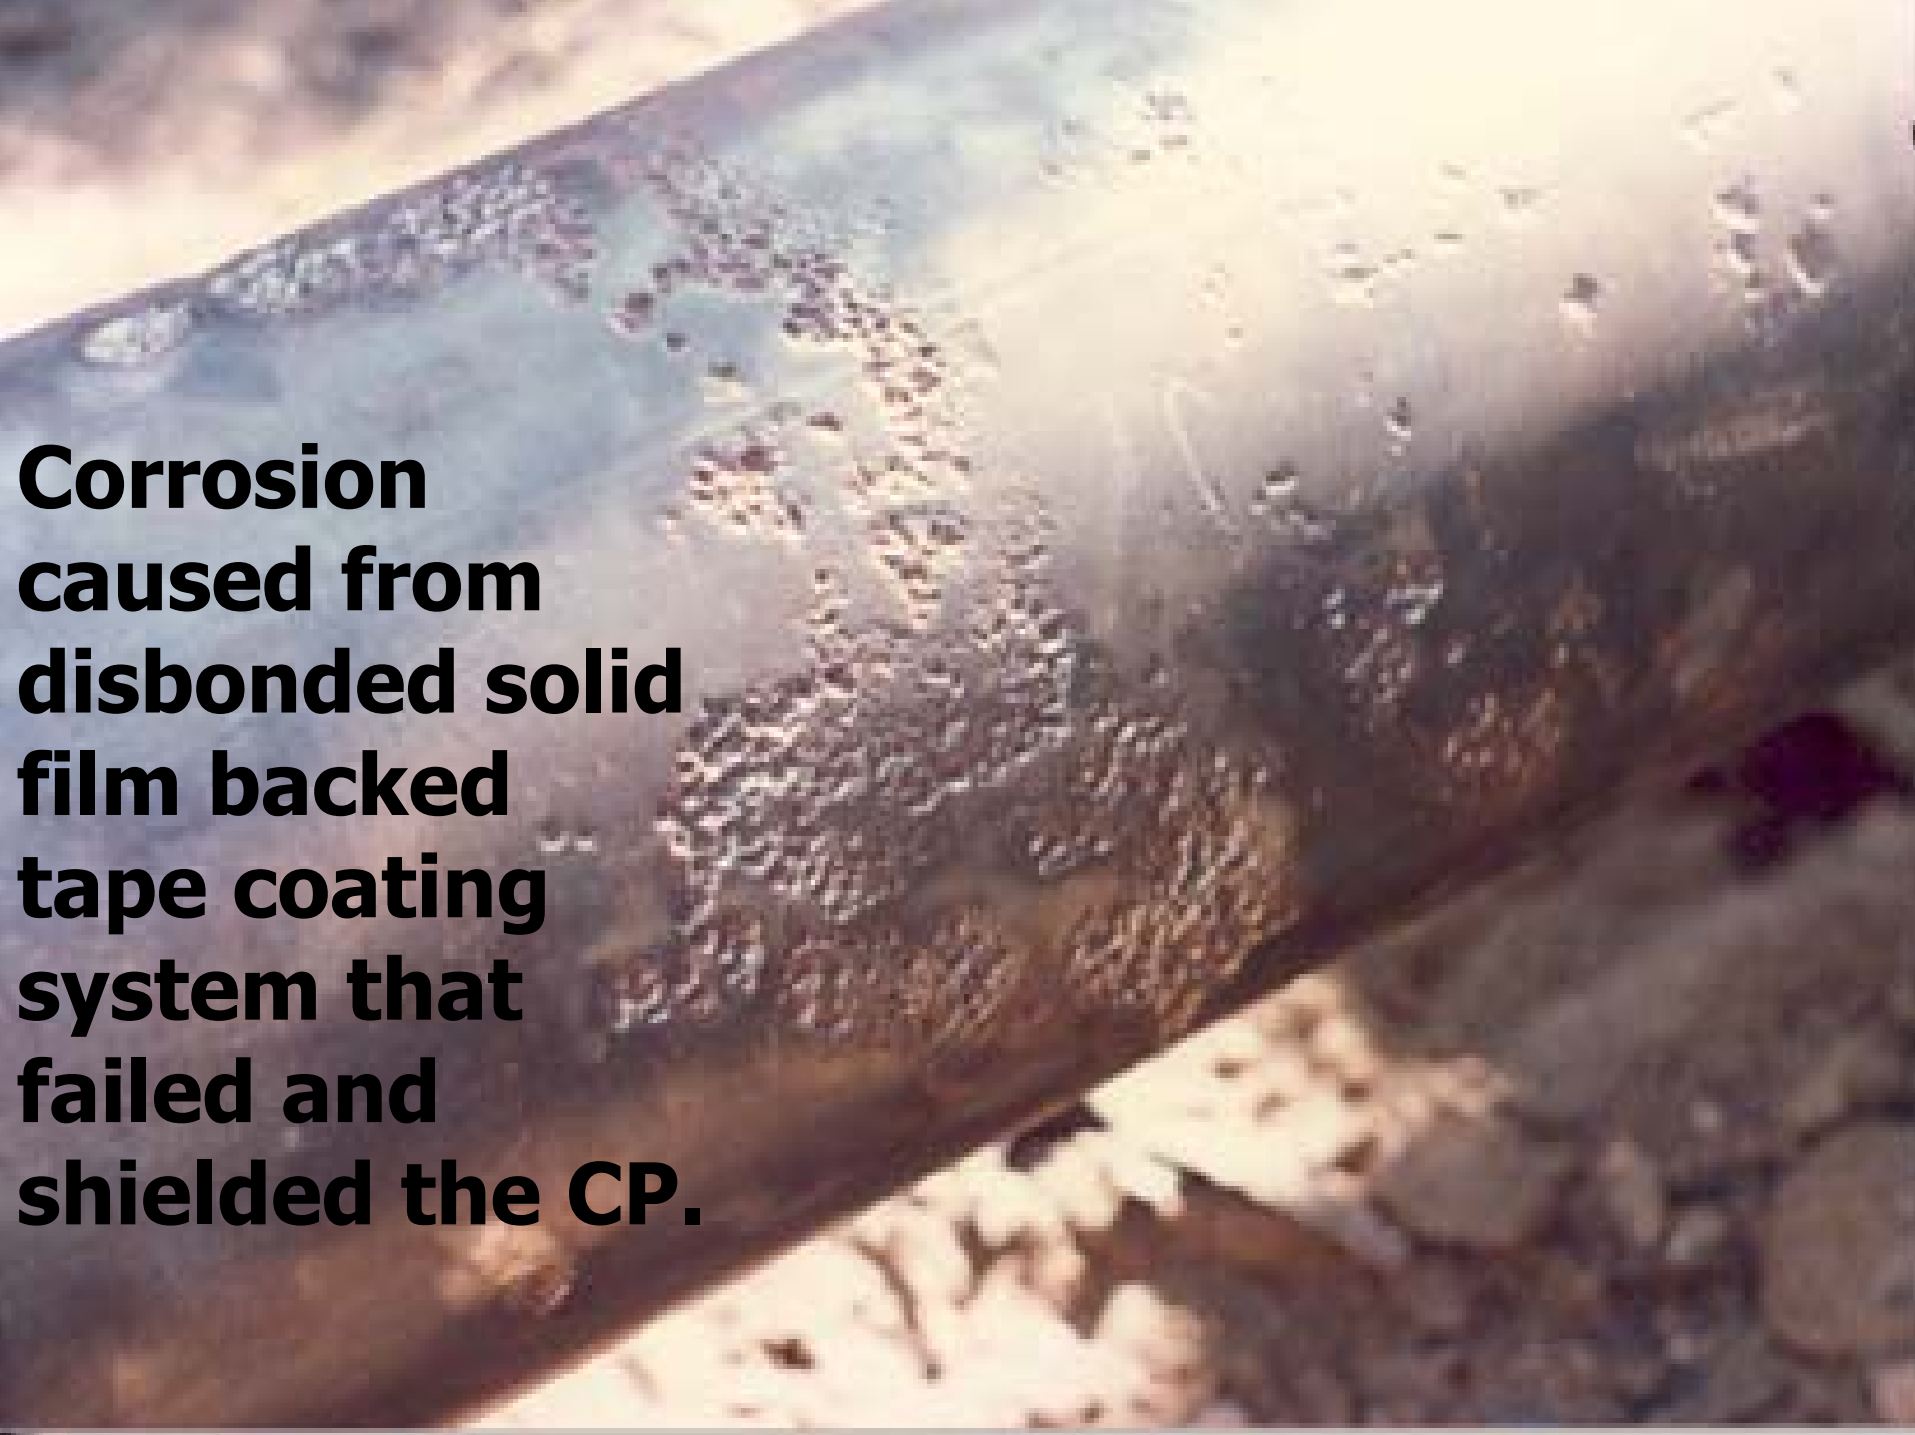
**Corrosion  
caused from  
disbonded solid  
film backed  
tape coating  
system that  
failed and  
shielded the CP.**

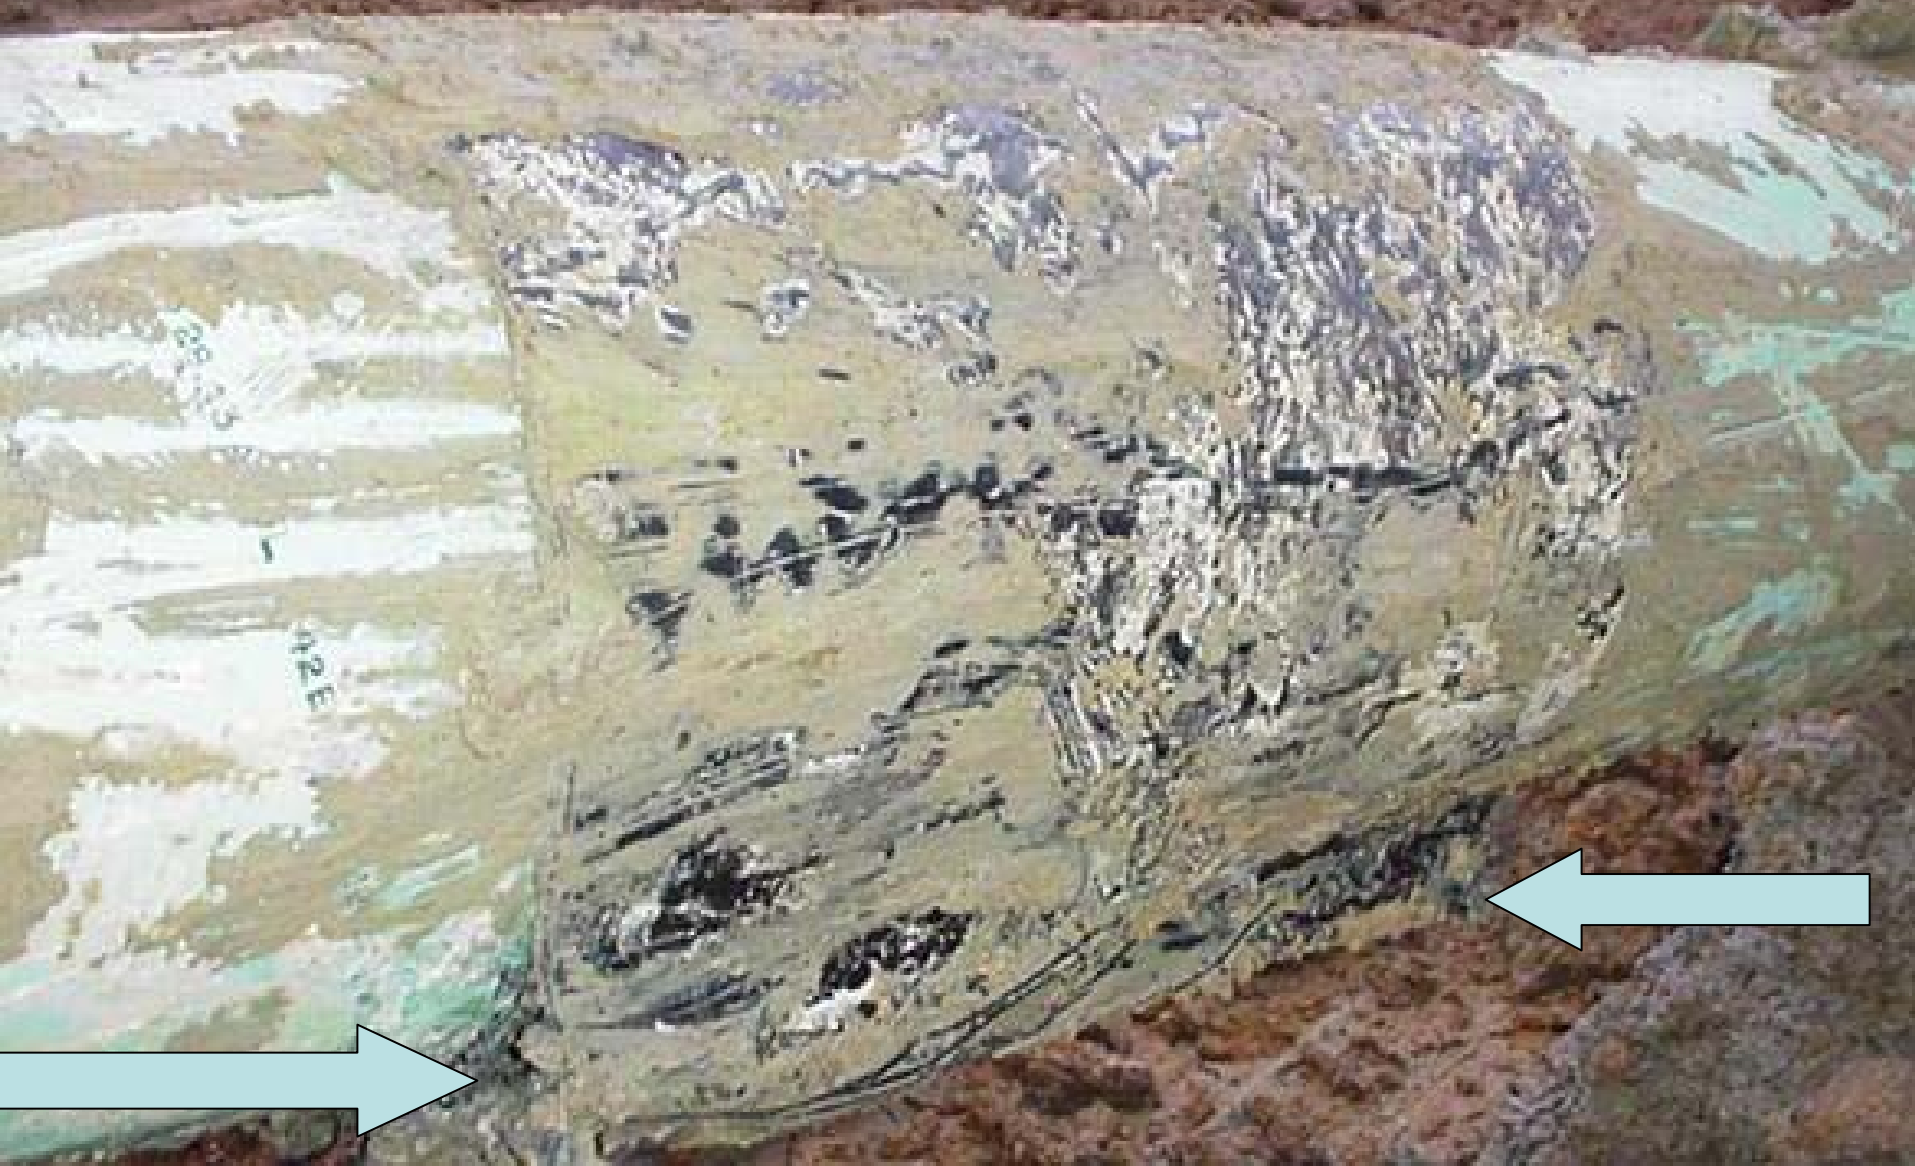
**Corrosion under  
shrink sleeve after  
eight years. No  
corrosion under FBE.  
Shrink sleeve was not  
“Fail Safe”!**

Soil stress has caused wrinkle in this shrink sleeve on a 10" pipe. See next slide for results.

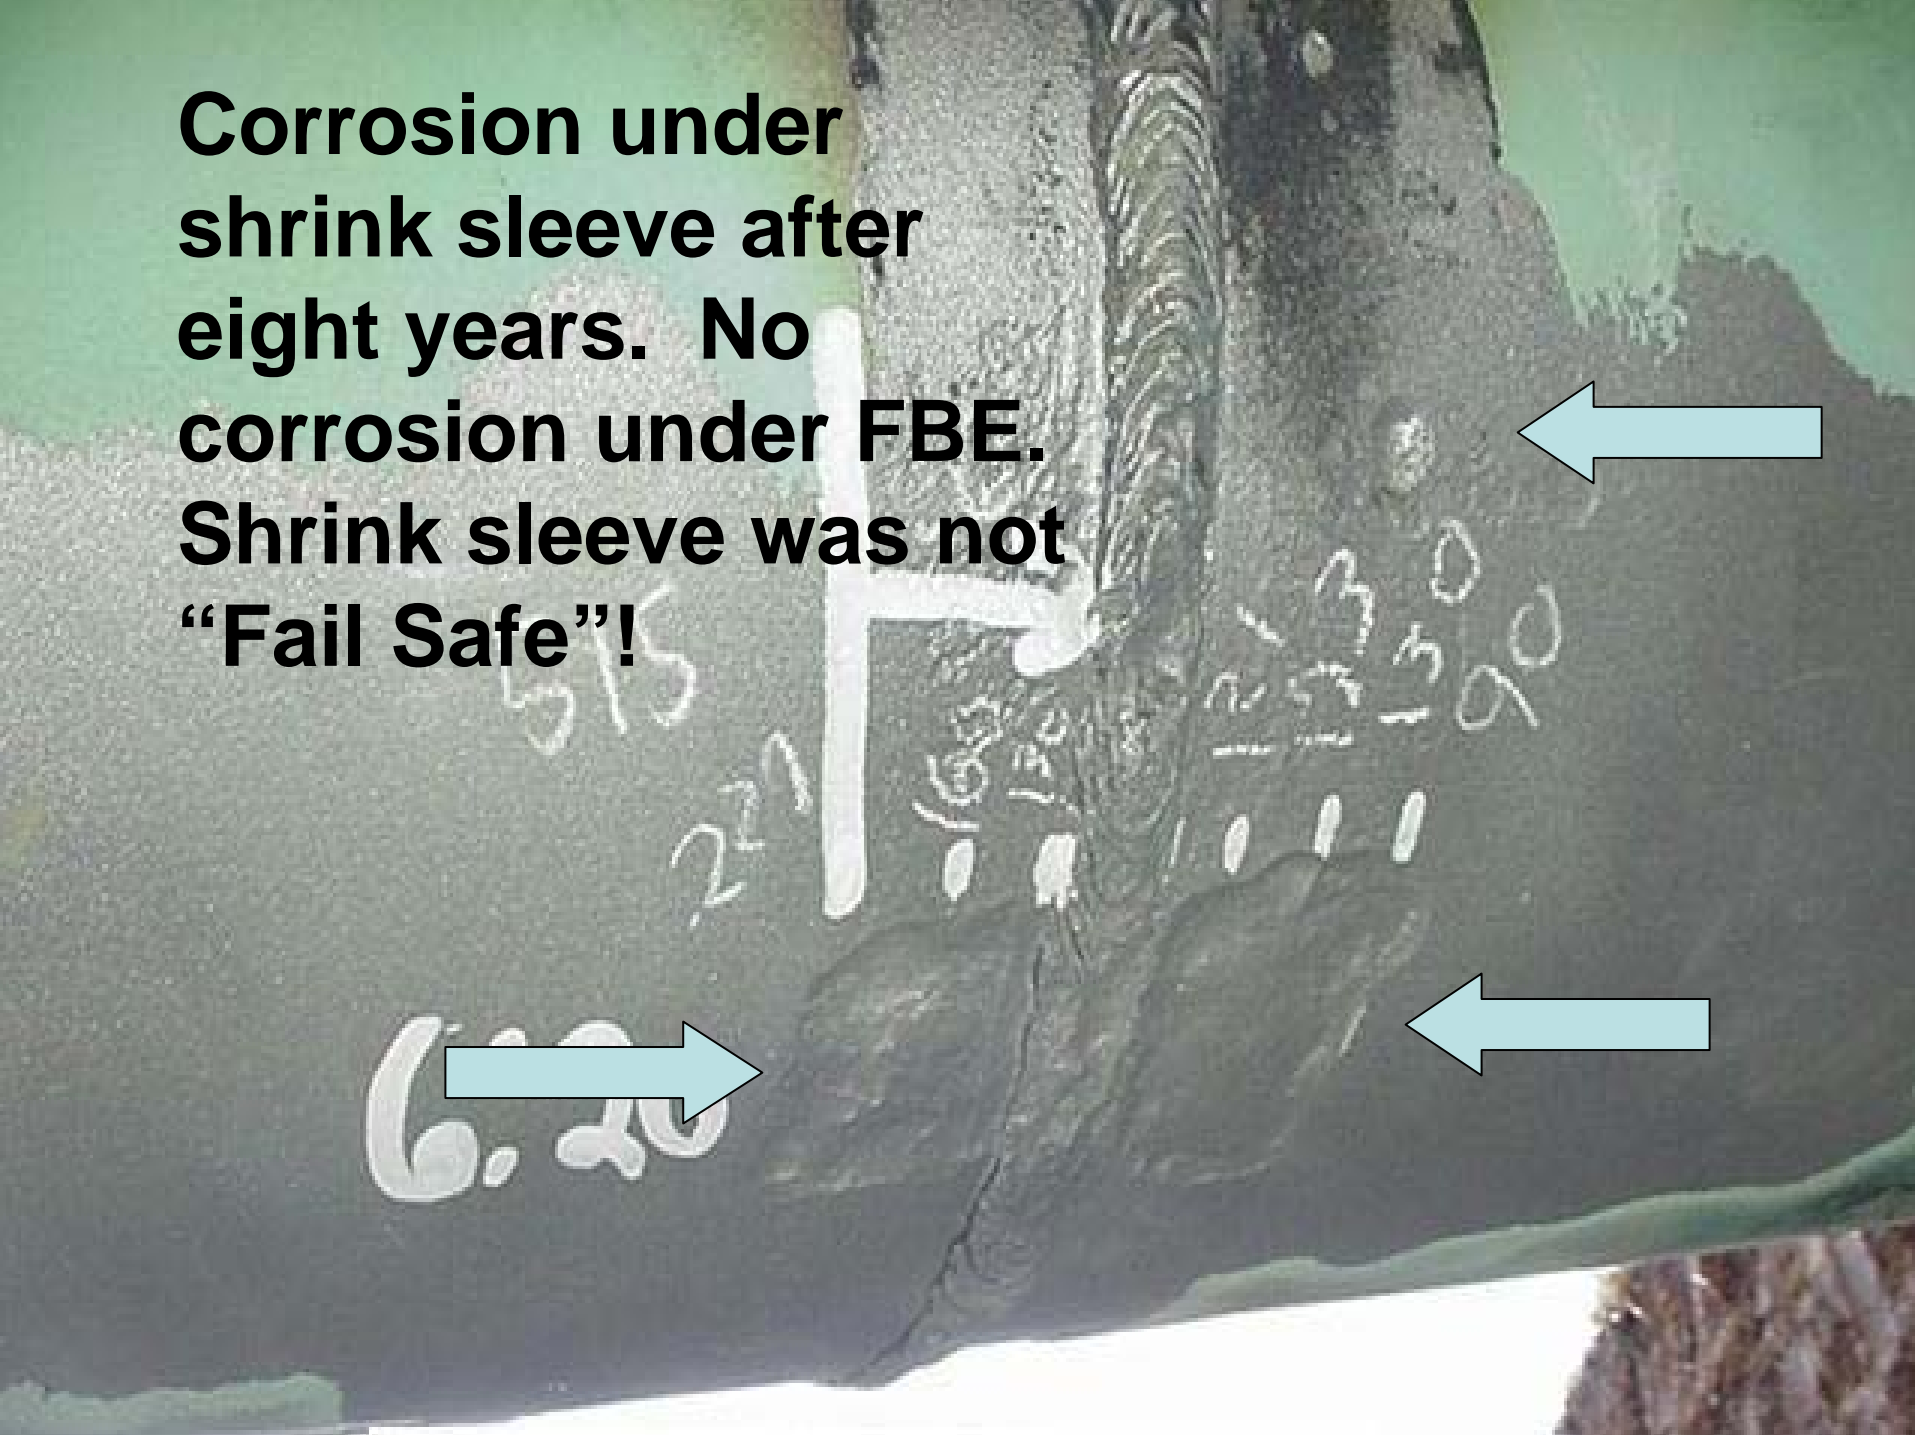
Lack of adhesion under shrink sleeve. Corrosion is developing because of shielding effects.

Not "Fail Safe".

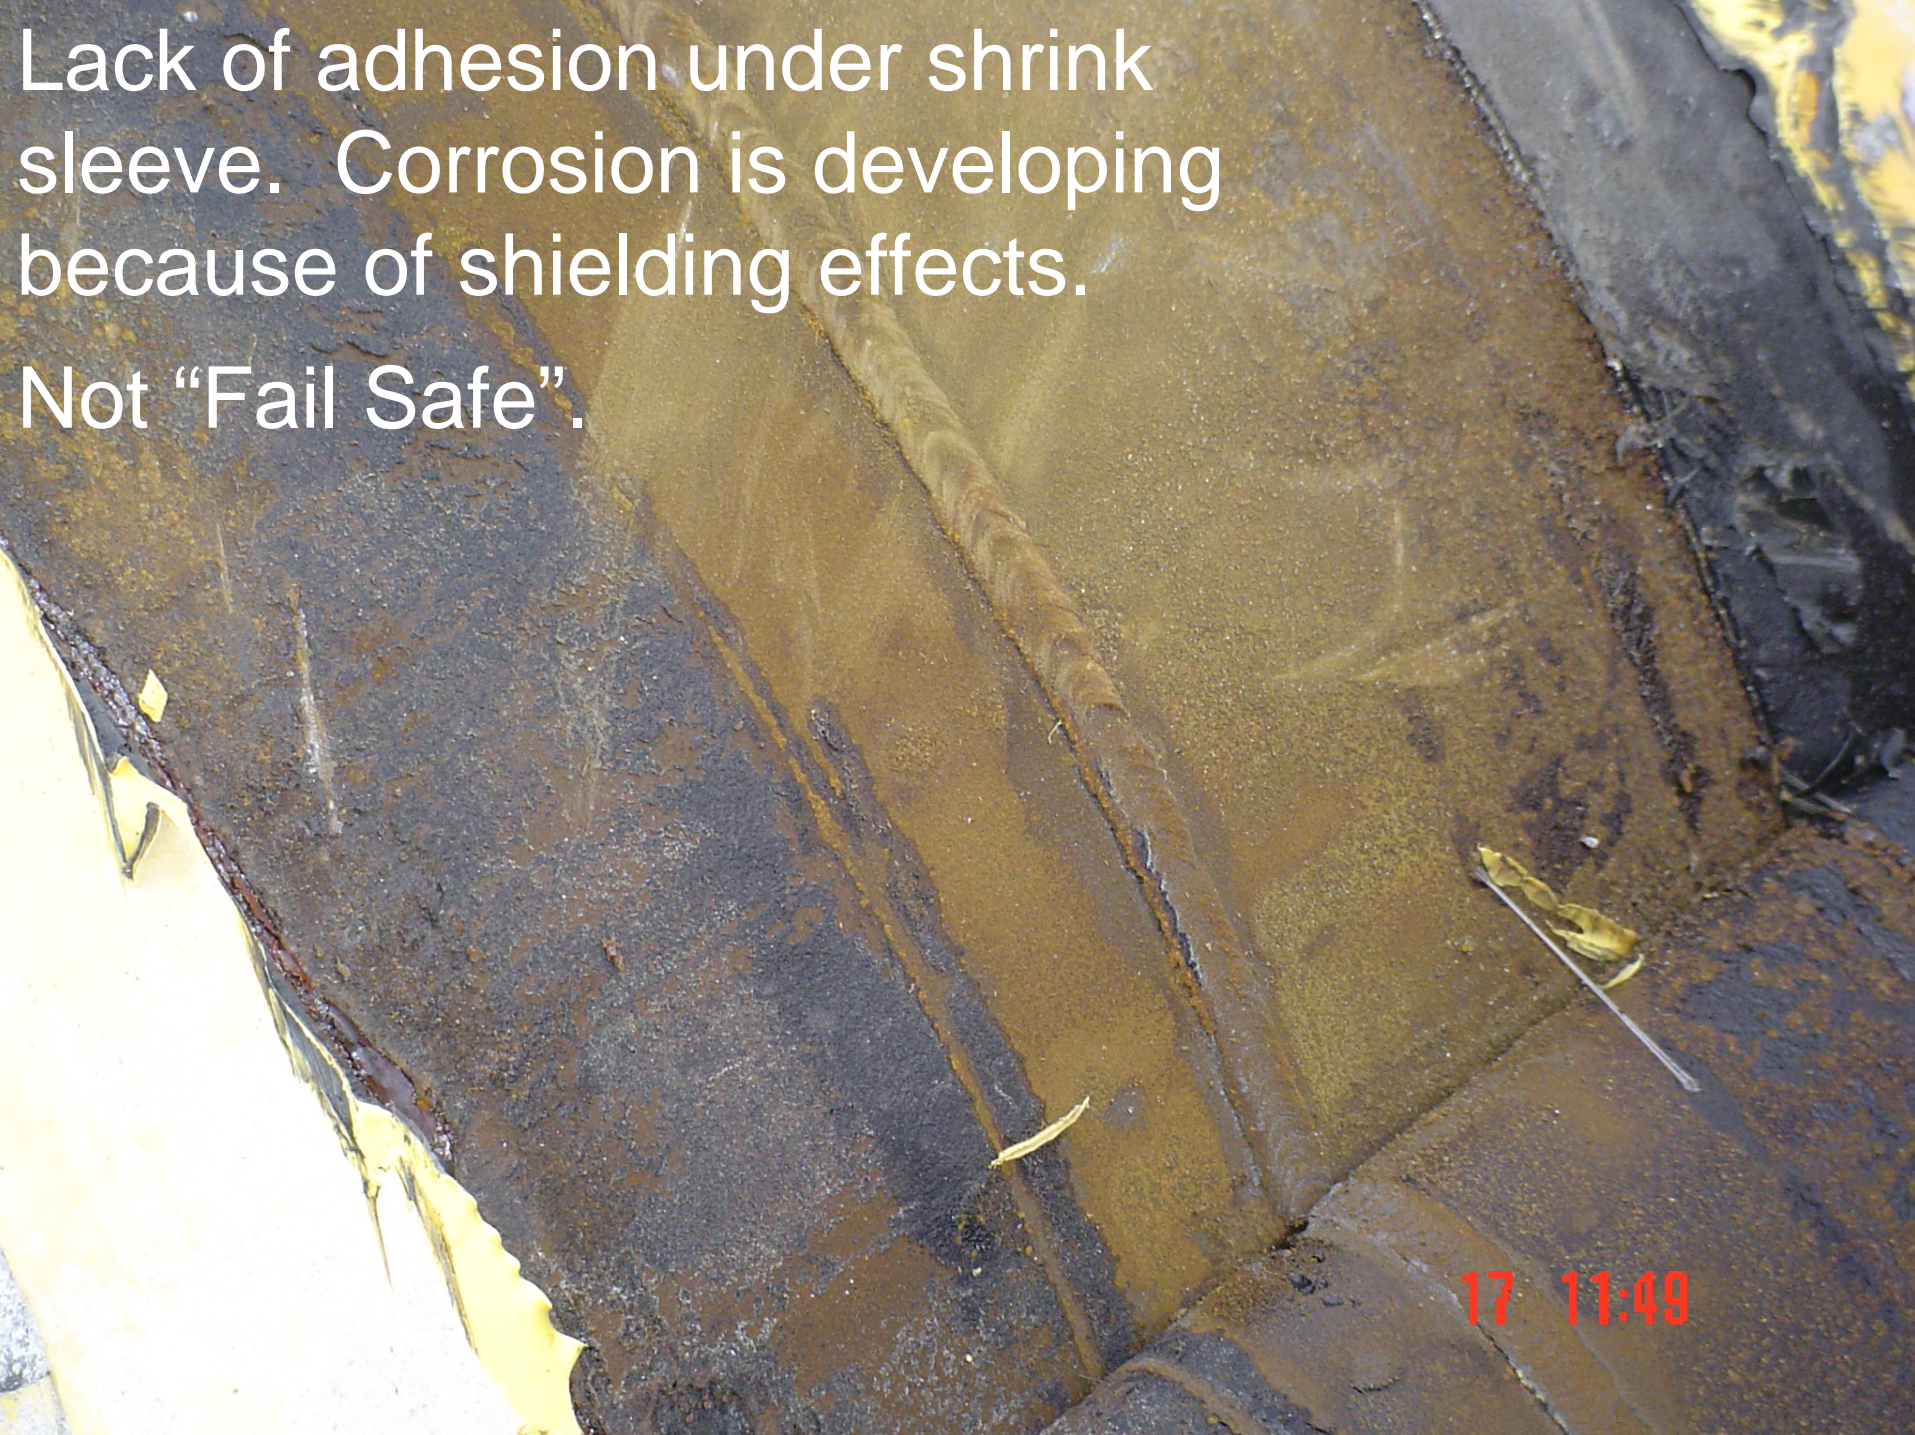
Severe soil stress caused coal tar coating to disbond. Notice dirt between the coating and pipe and pipe.

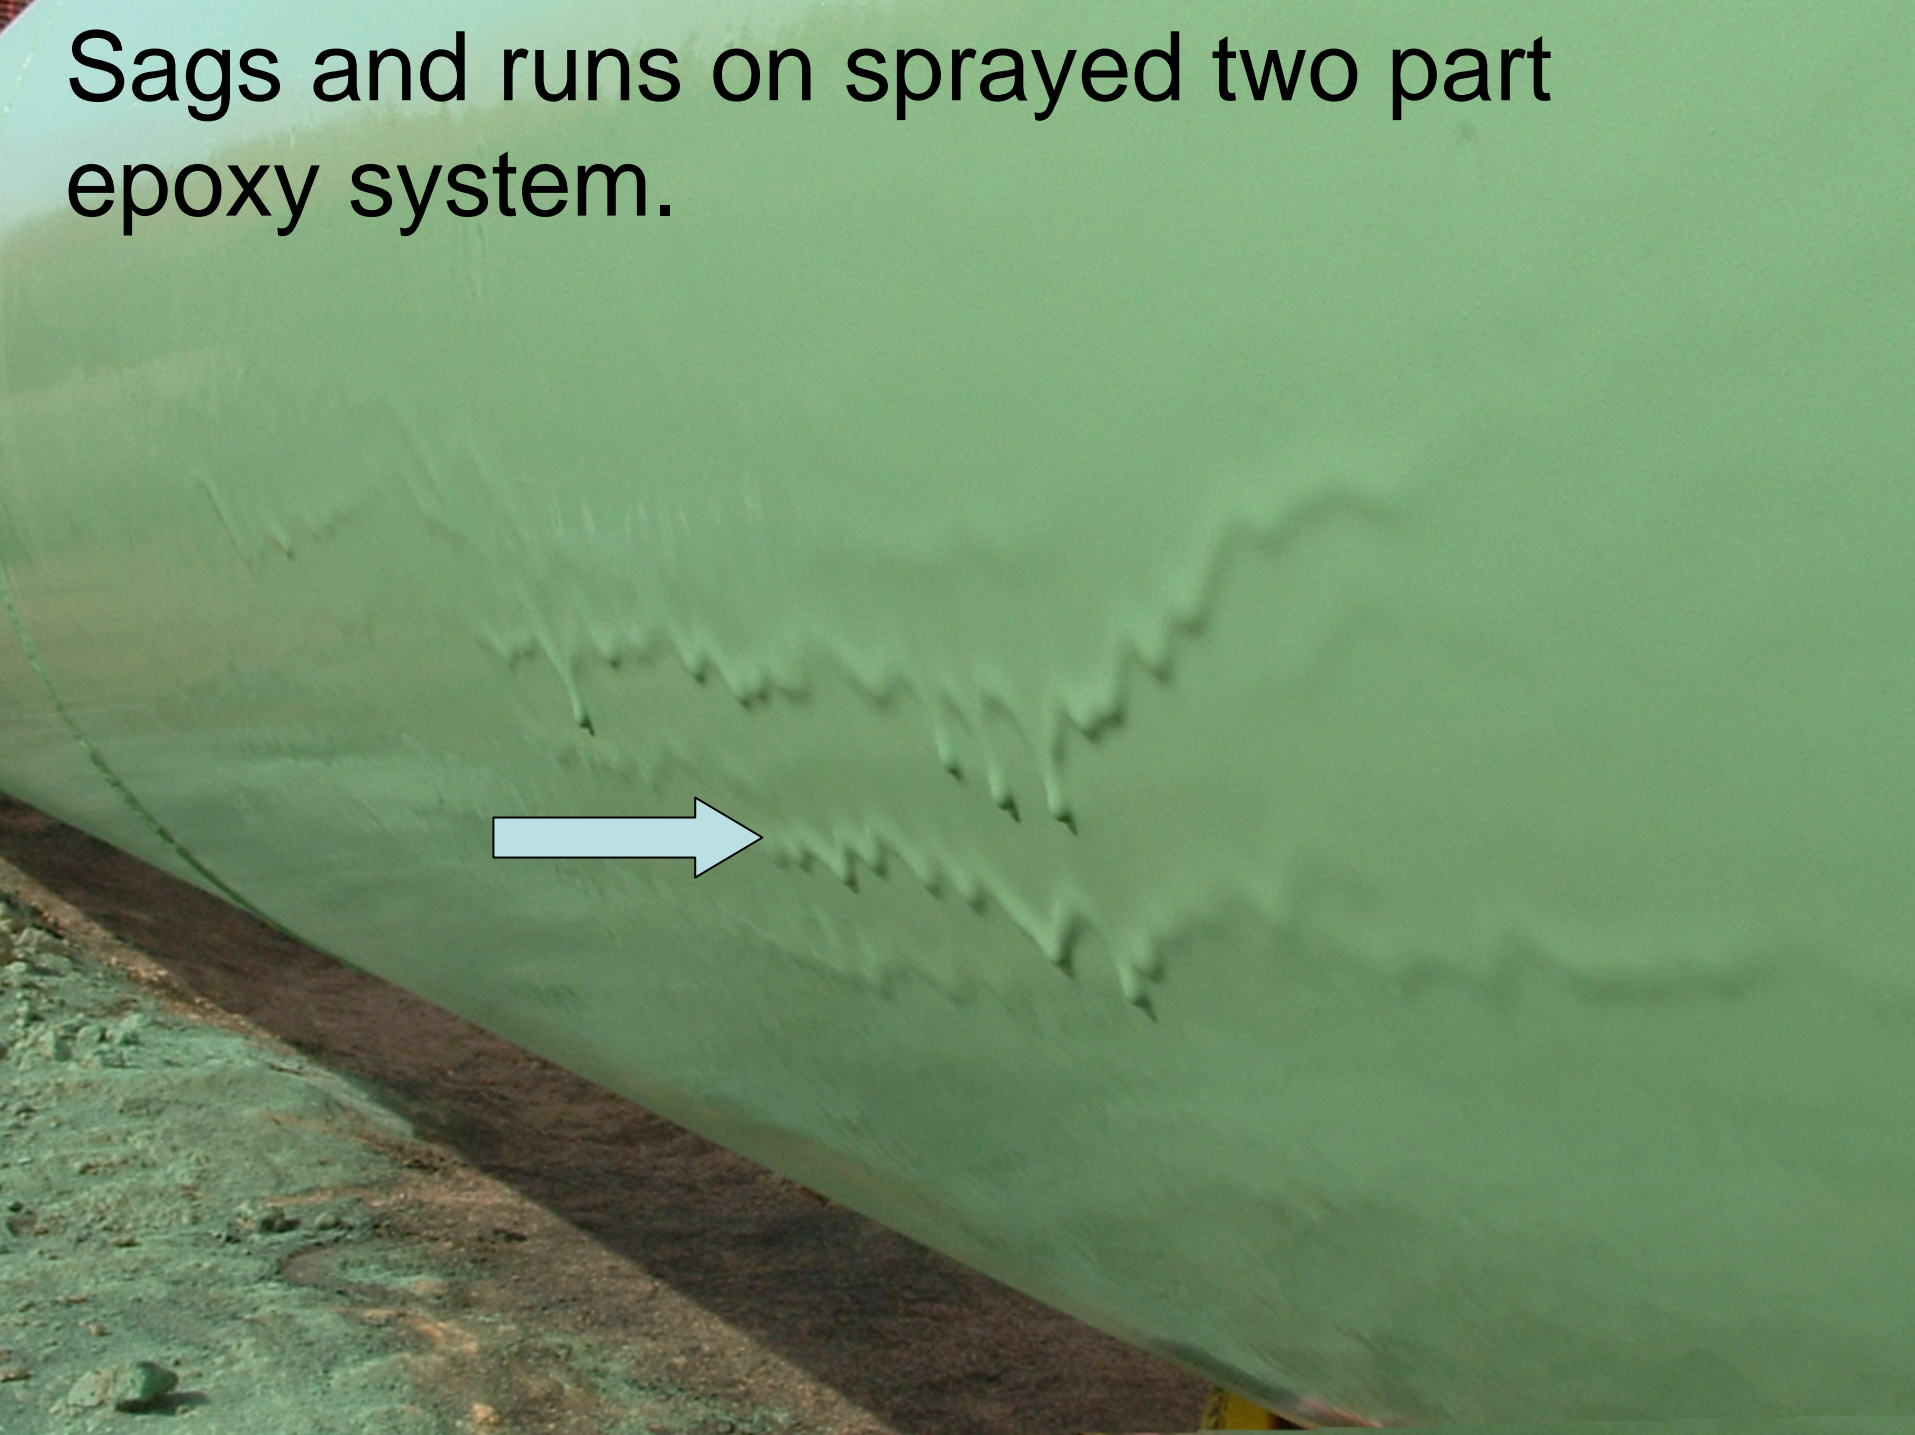
Sags and runs on sprayed two part epoxy system.

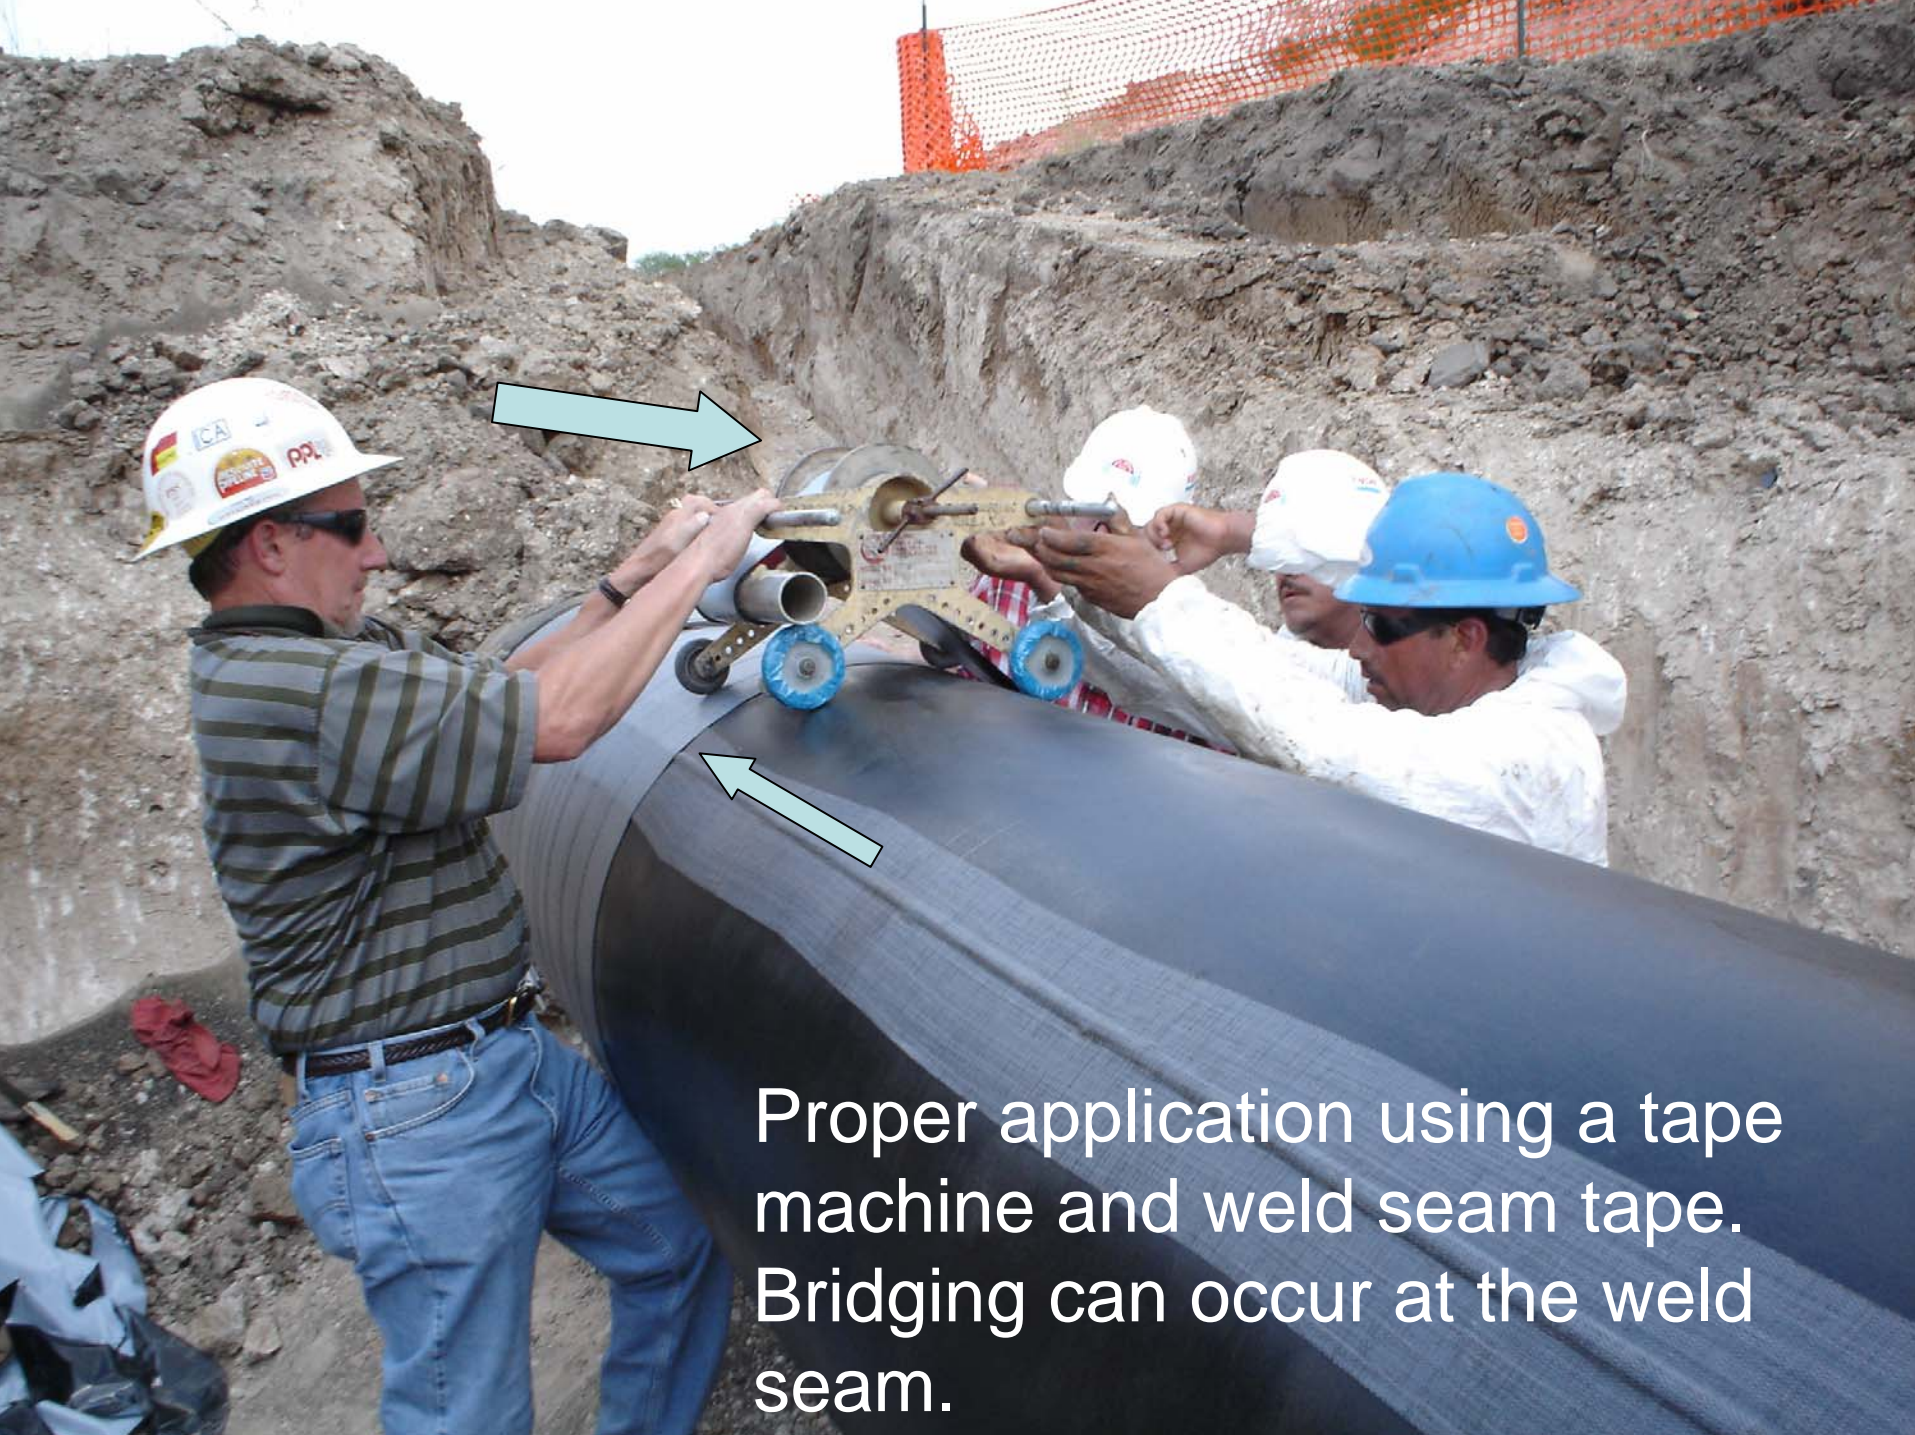
Proper application using a tape machine and weld seam tape. Bridging can occur at the weld seam.

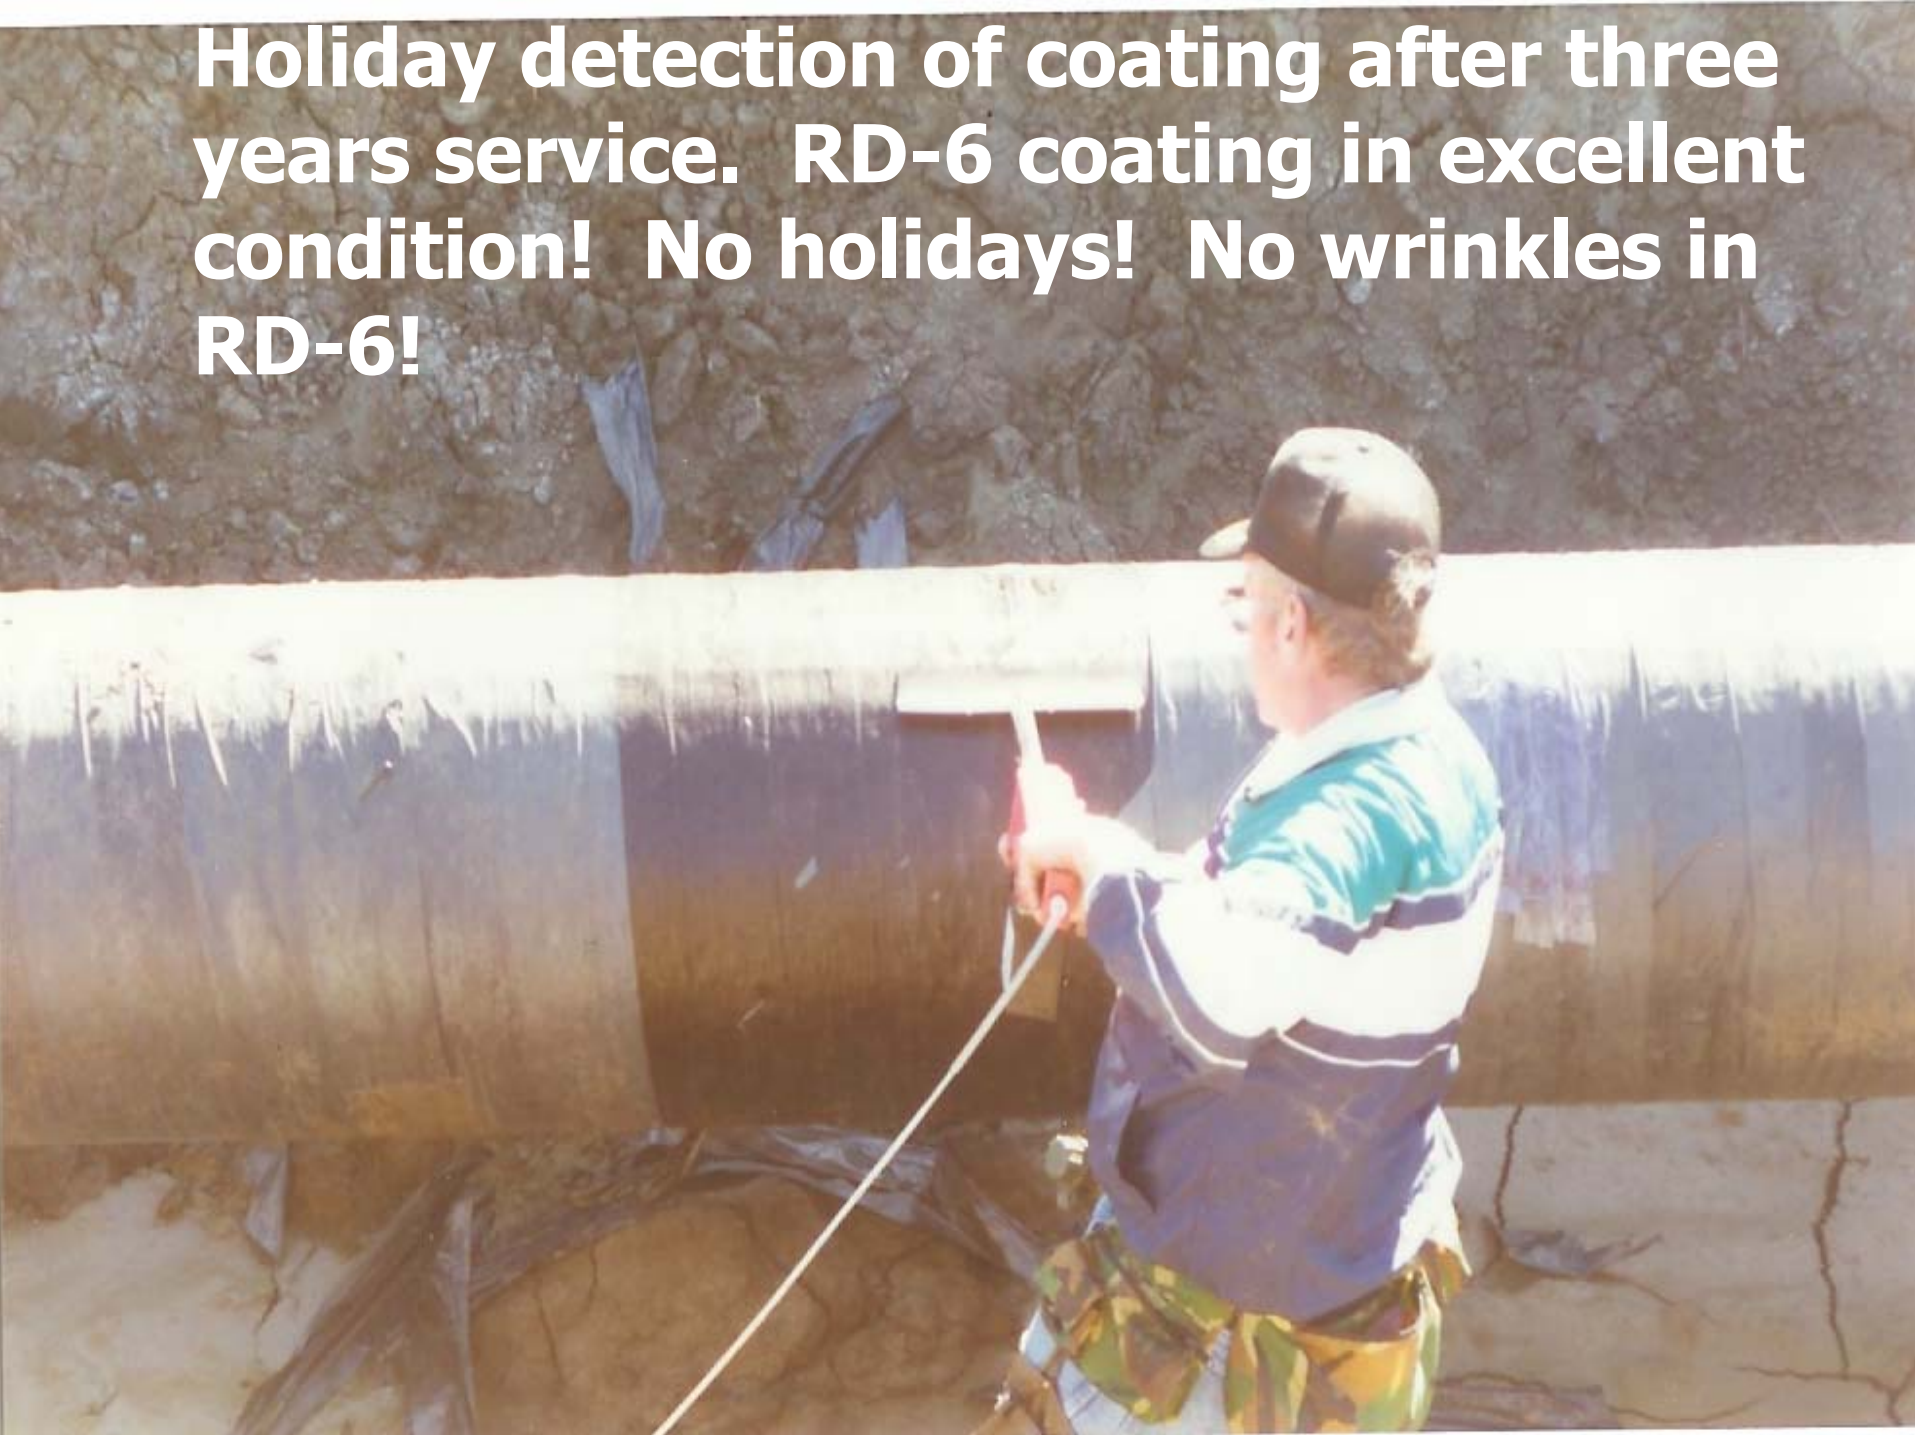
Evaluation of RD-6 after three years of service in Greenville, MS. Serious soil stress area. Outer wrap wrinkled. See next slide.

**Holiday detection of coating after three years service. RD-6 coating in excellent condition! No holidays! No wrinkles in RD-6!**

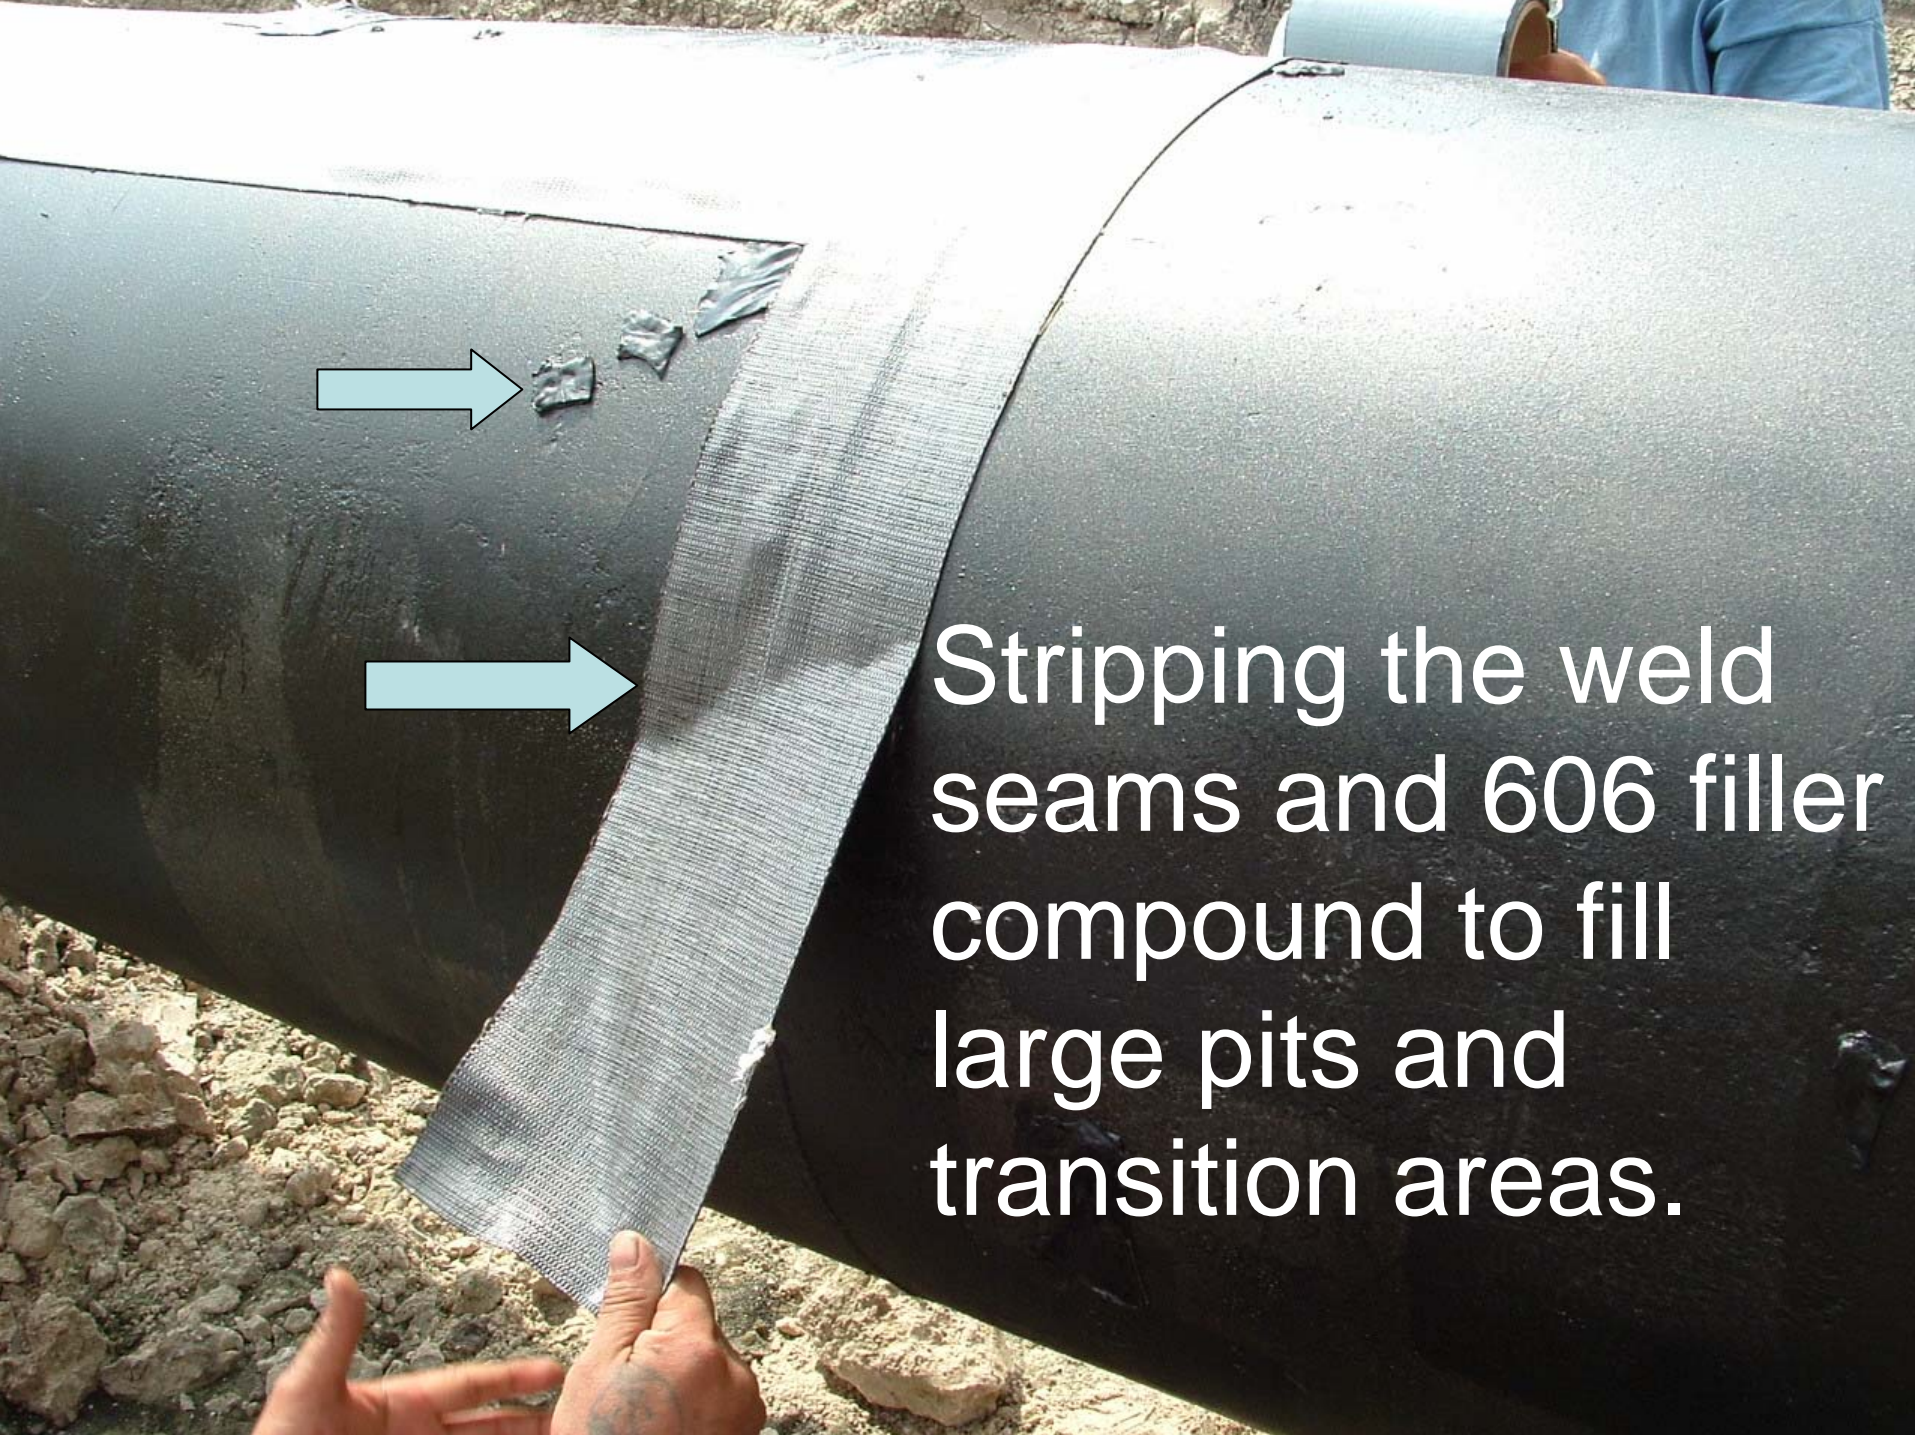
The weld seams should be stripped to prevent the soil pressure from moving the compound and leaving a thinner coating at the weld.
