# POLYGUARD RD-6

**“A FAIL SAFE” PIPELINE**

**COATING SYSTEM**

**FOR REHABILITATION OR**

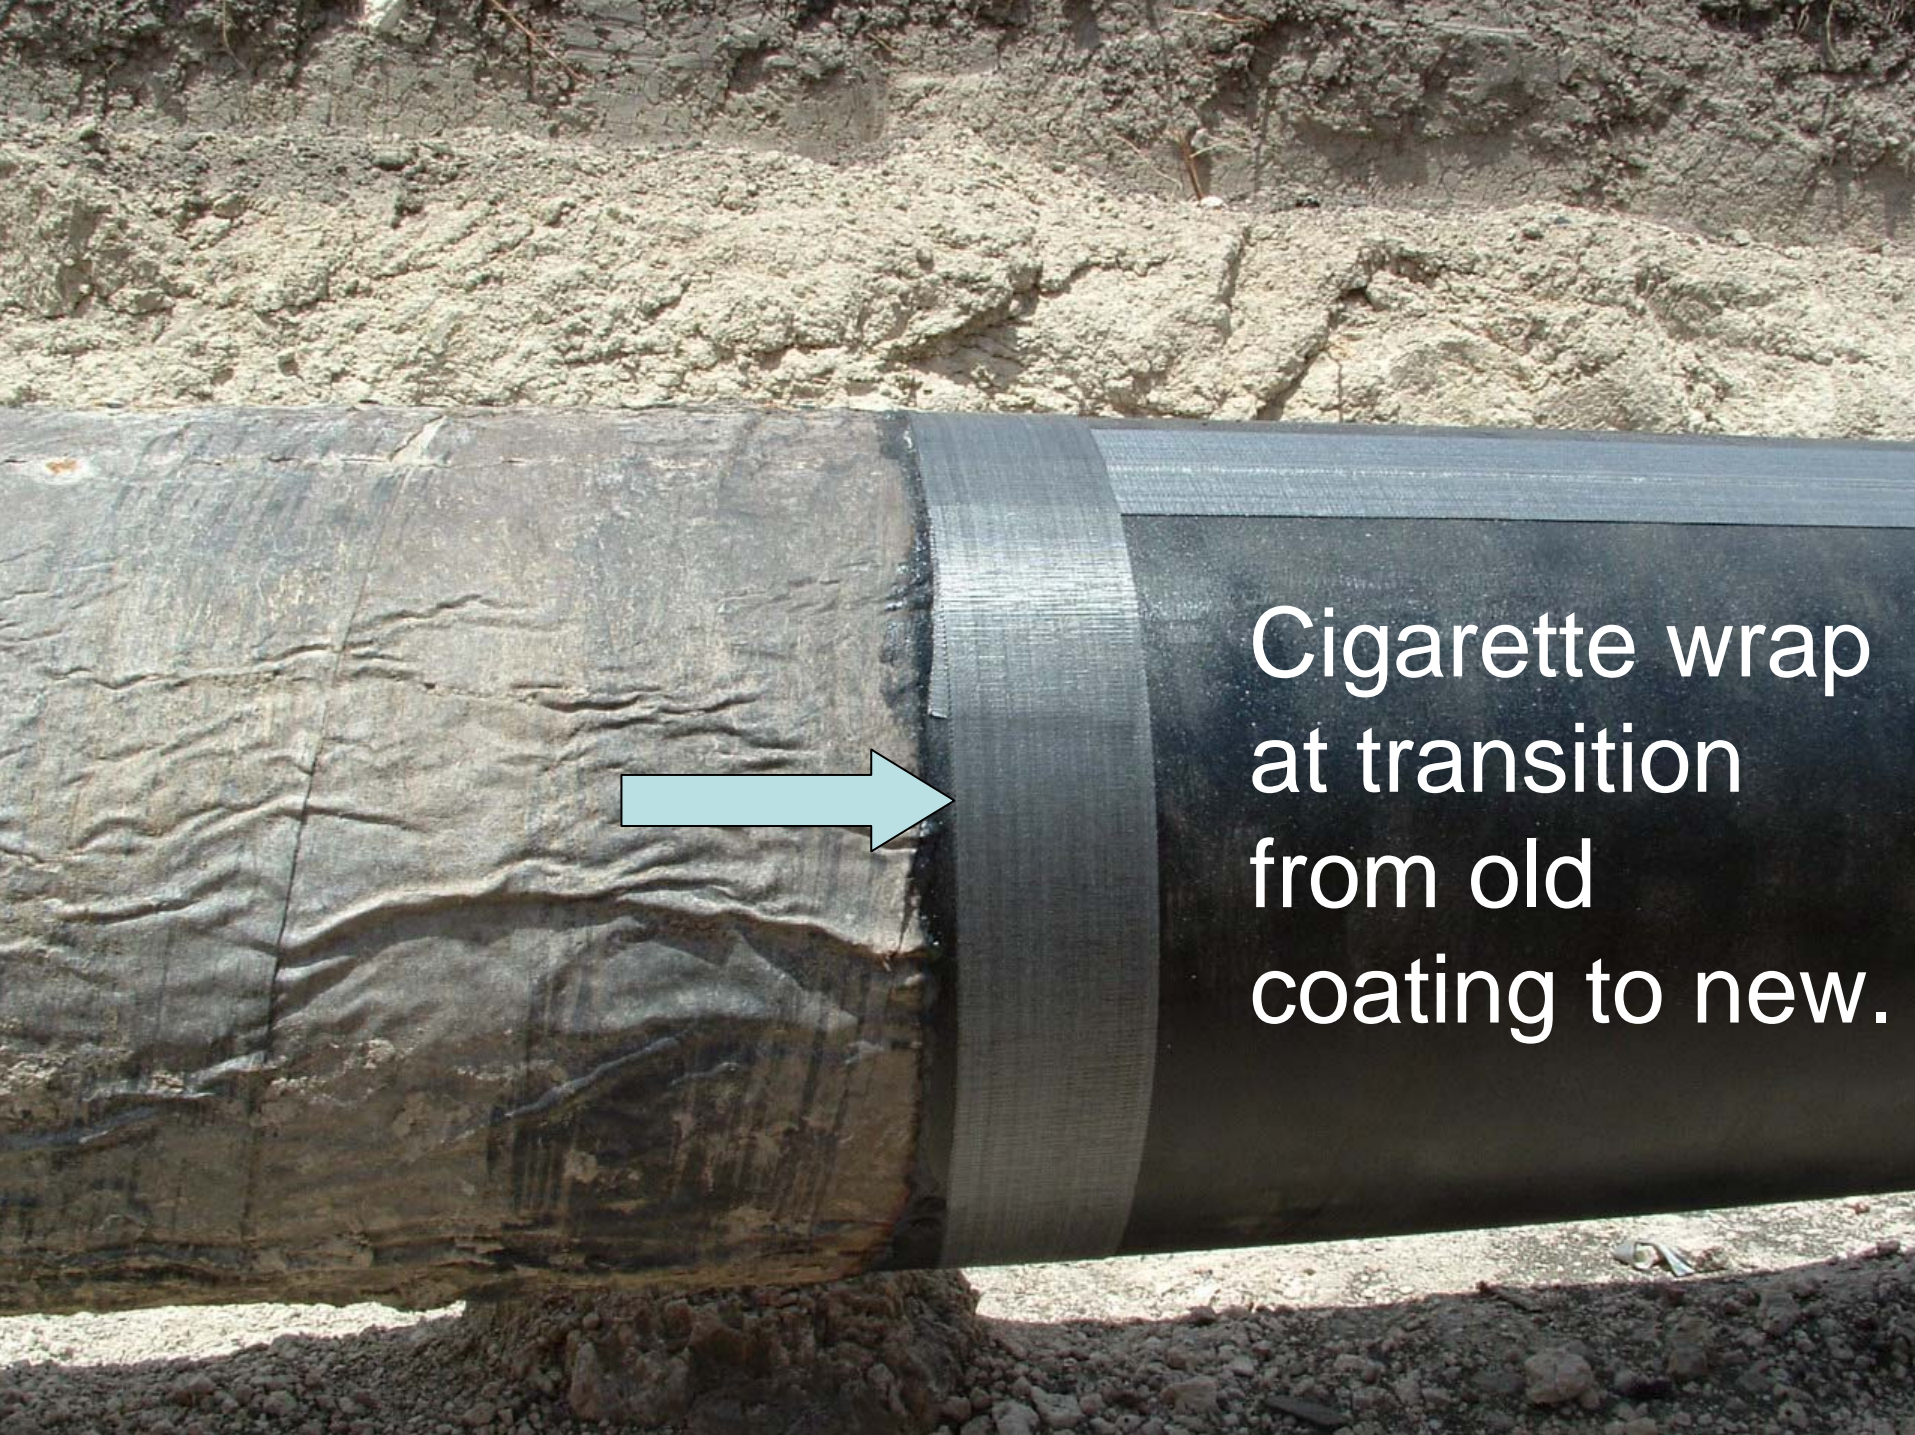
Stripping the weld seams and 606 filler compound to fill large pits and transition areas.

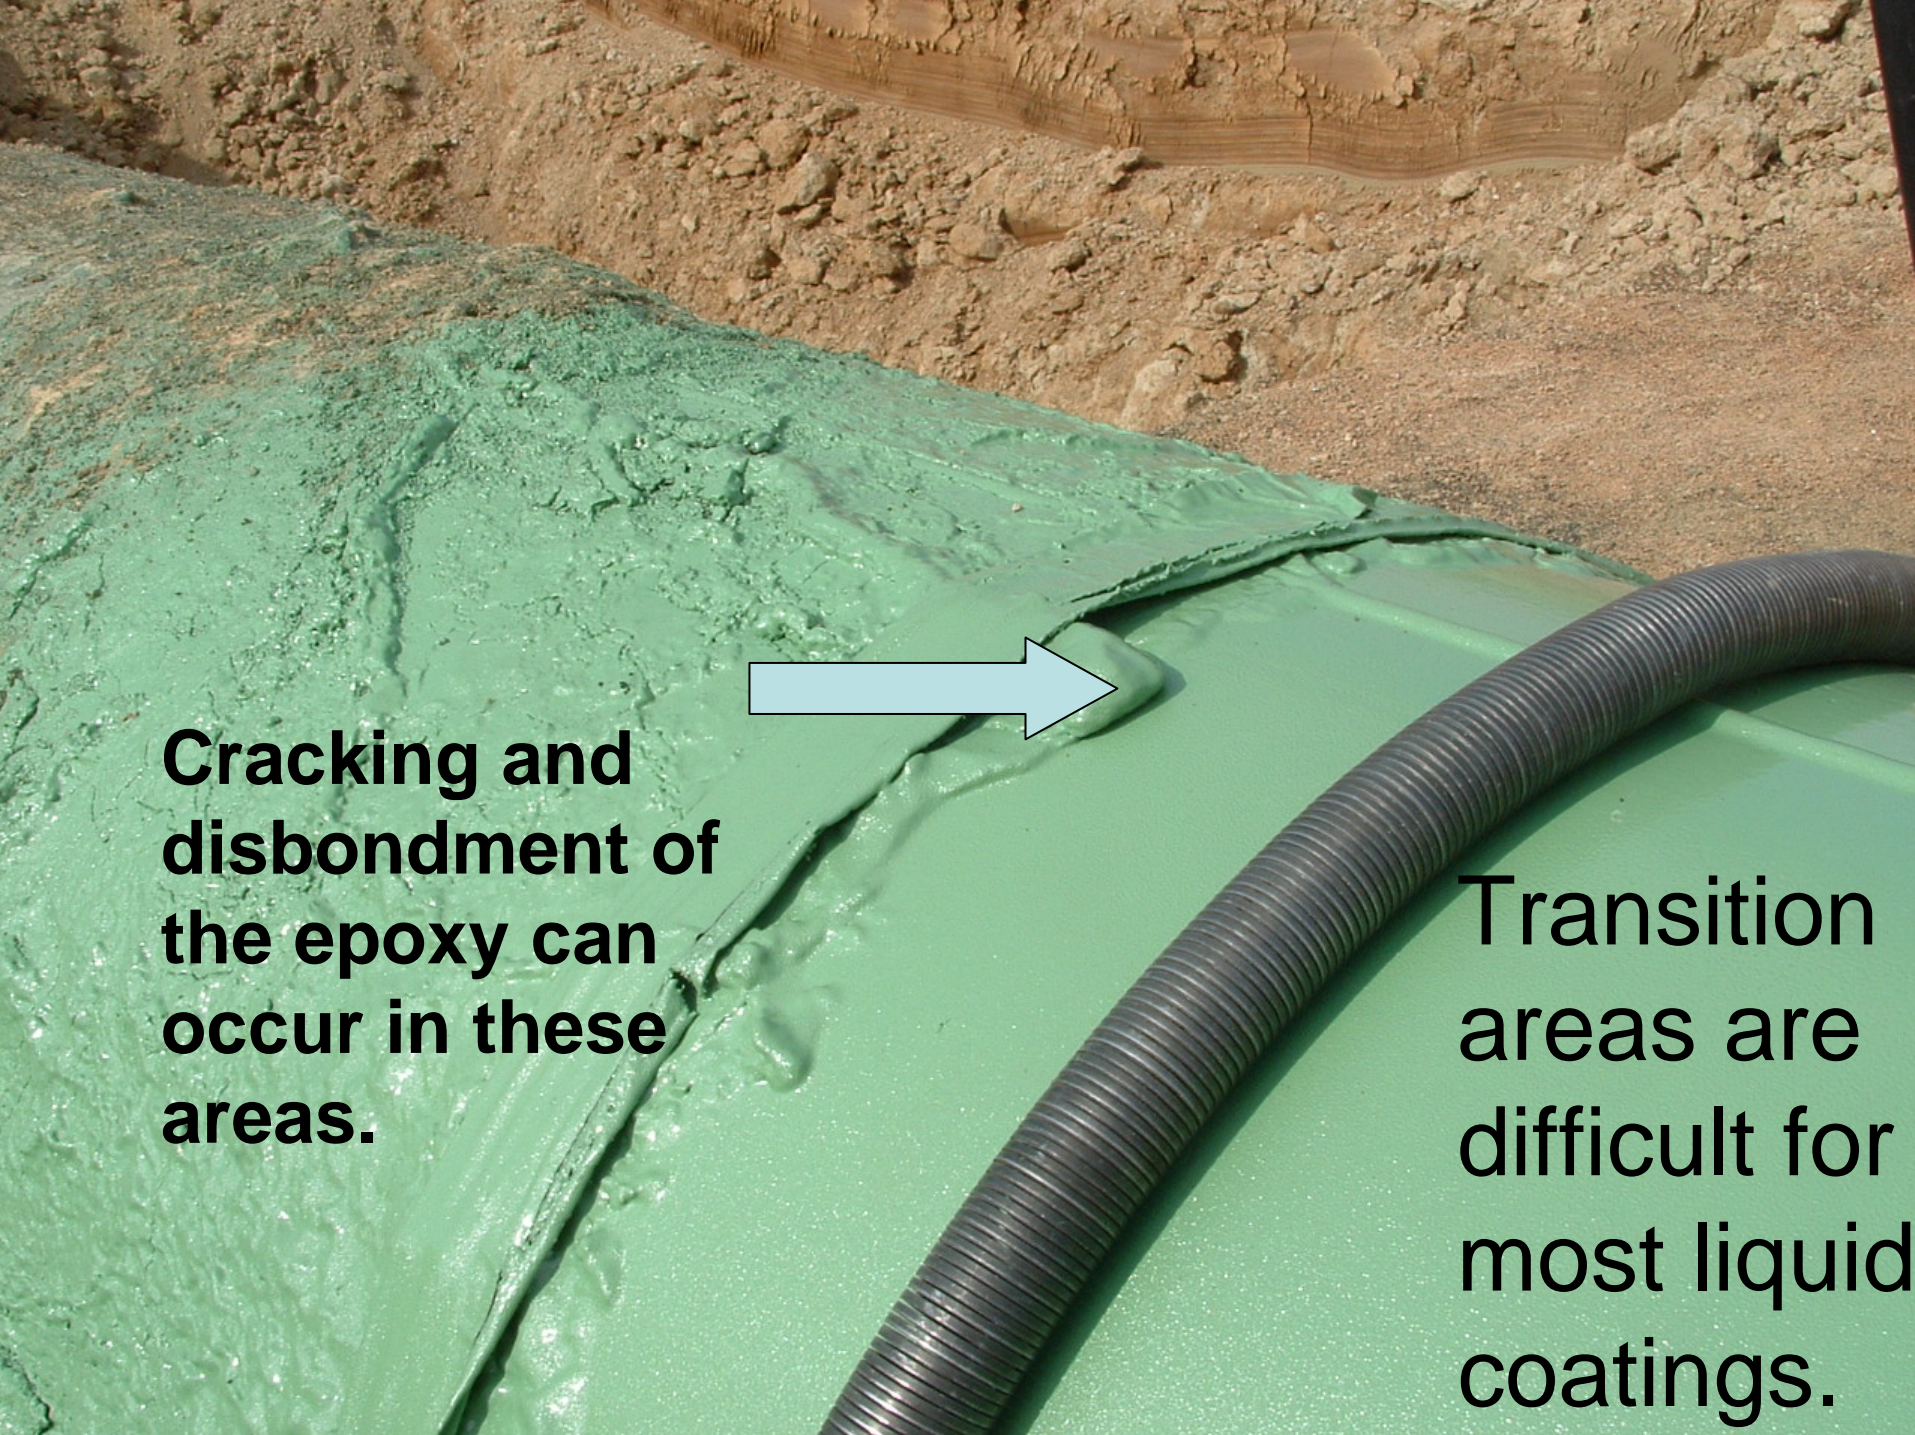
Cigarette wrap  
at transition  
from old  
coating to new.

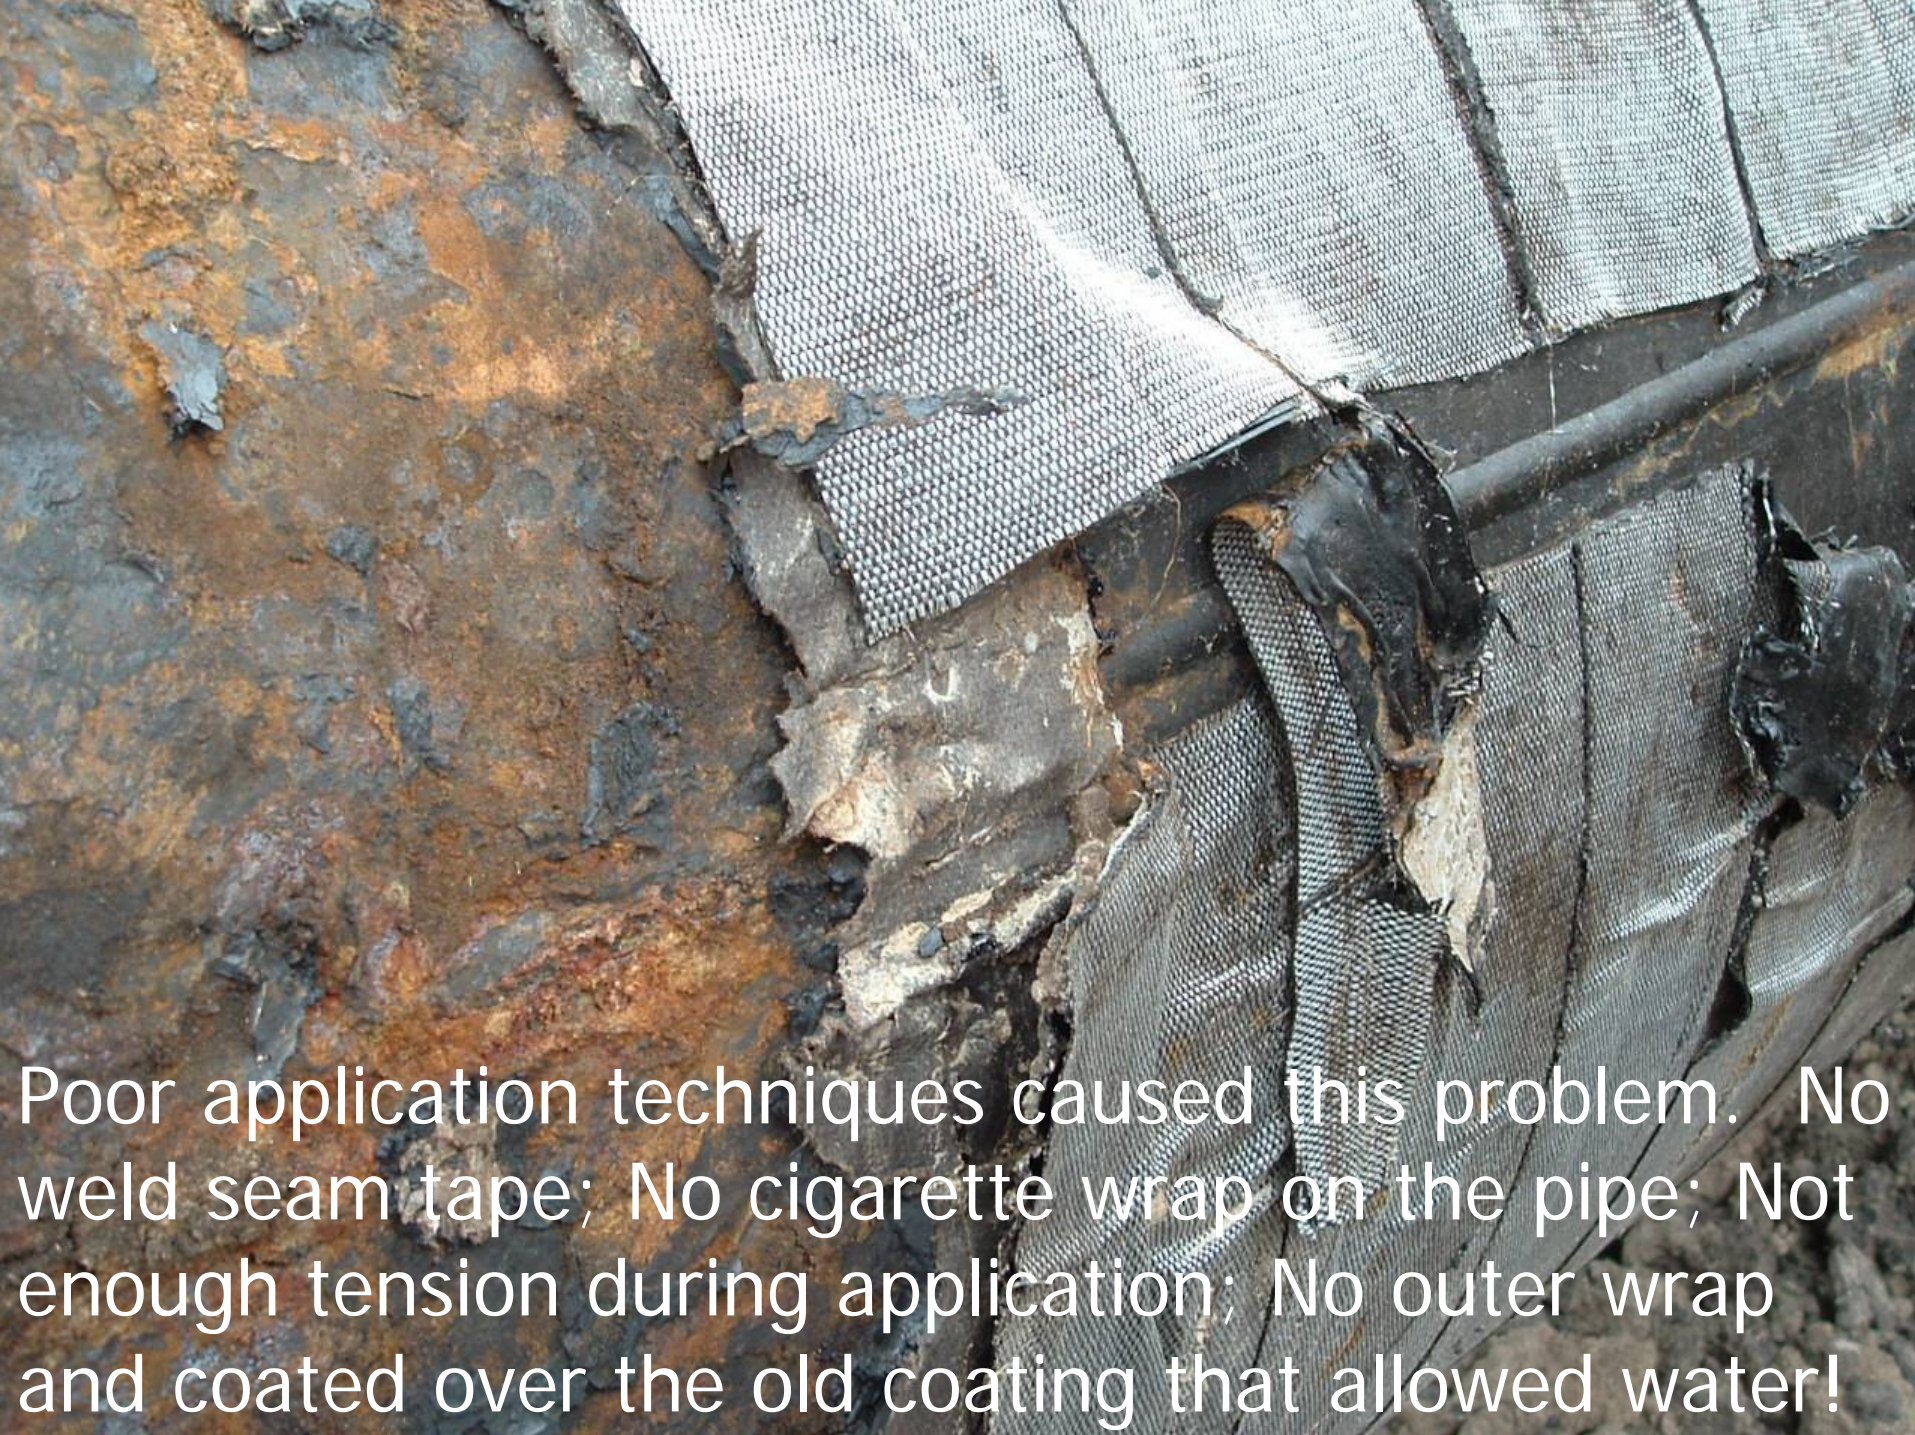
Poor application techniques caused this problem. No weld seam tape; No cigarette wrap on the pipe; Not enough tension during application; No outer wrap and coated over the old coating that allowed water!

The compound was displaced at weld seam because it was not stripped leaving little or no compound. Notice some flash rusting from areas not primed properly along weld seam.

**The next slide shows the only known site (after over 15 yrs) that the RD-6 coating actually had wrinkles and water under the coating. The RD-6 was applied without proper tension, no outer wrap, no stripping of the weld seams and at the transition, it was applied directly over the old coal tar coating allowing water to penetrate under the RD-6. This experience provided us with opportunity to prove the “FAIL SAFE” in the field!**

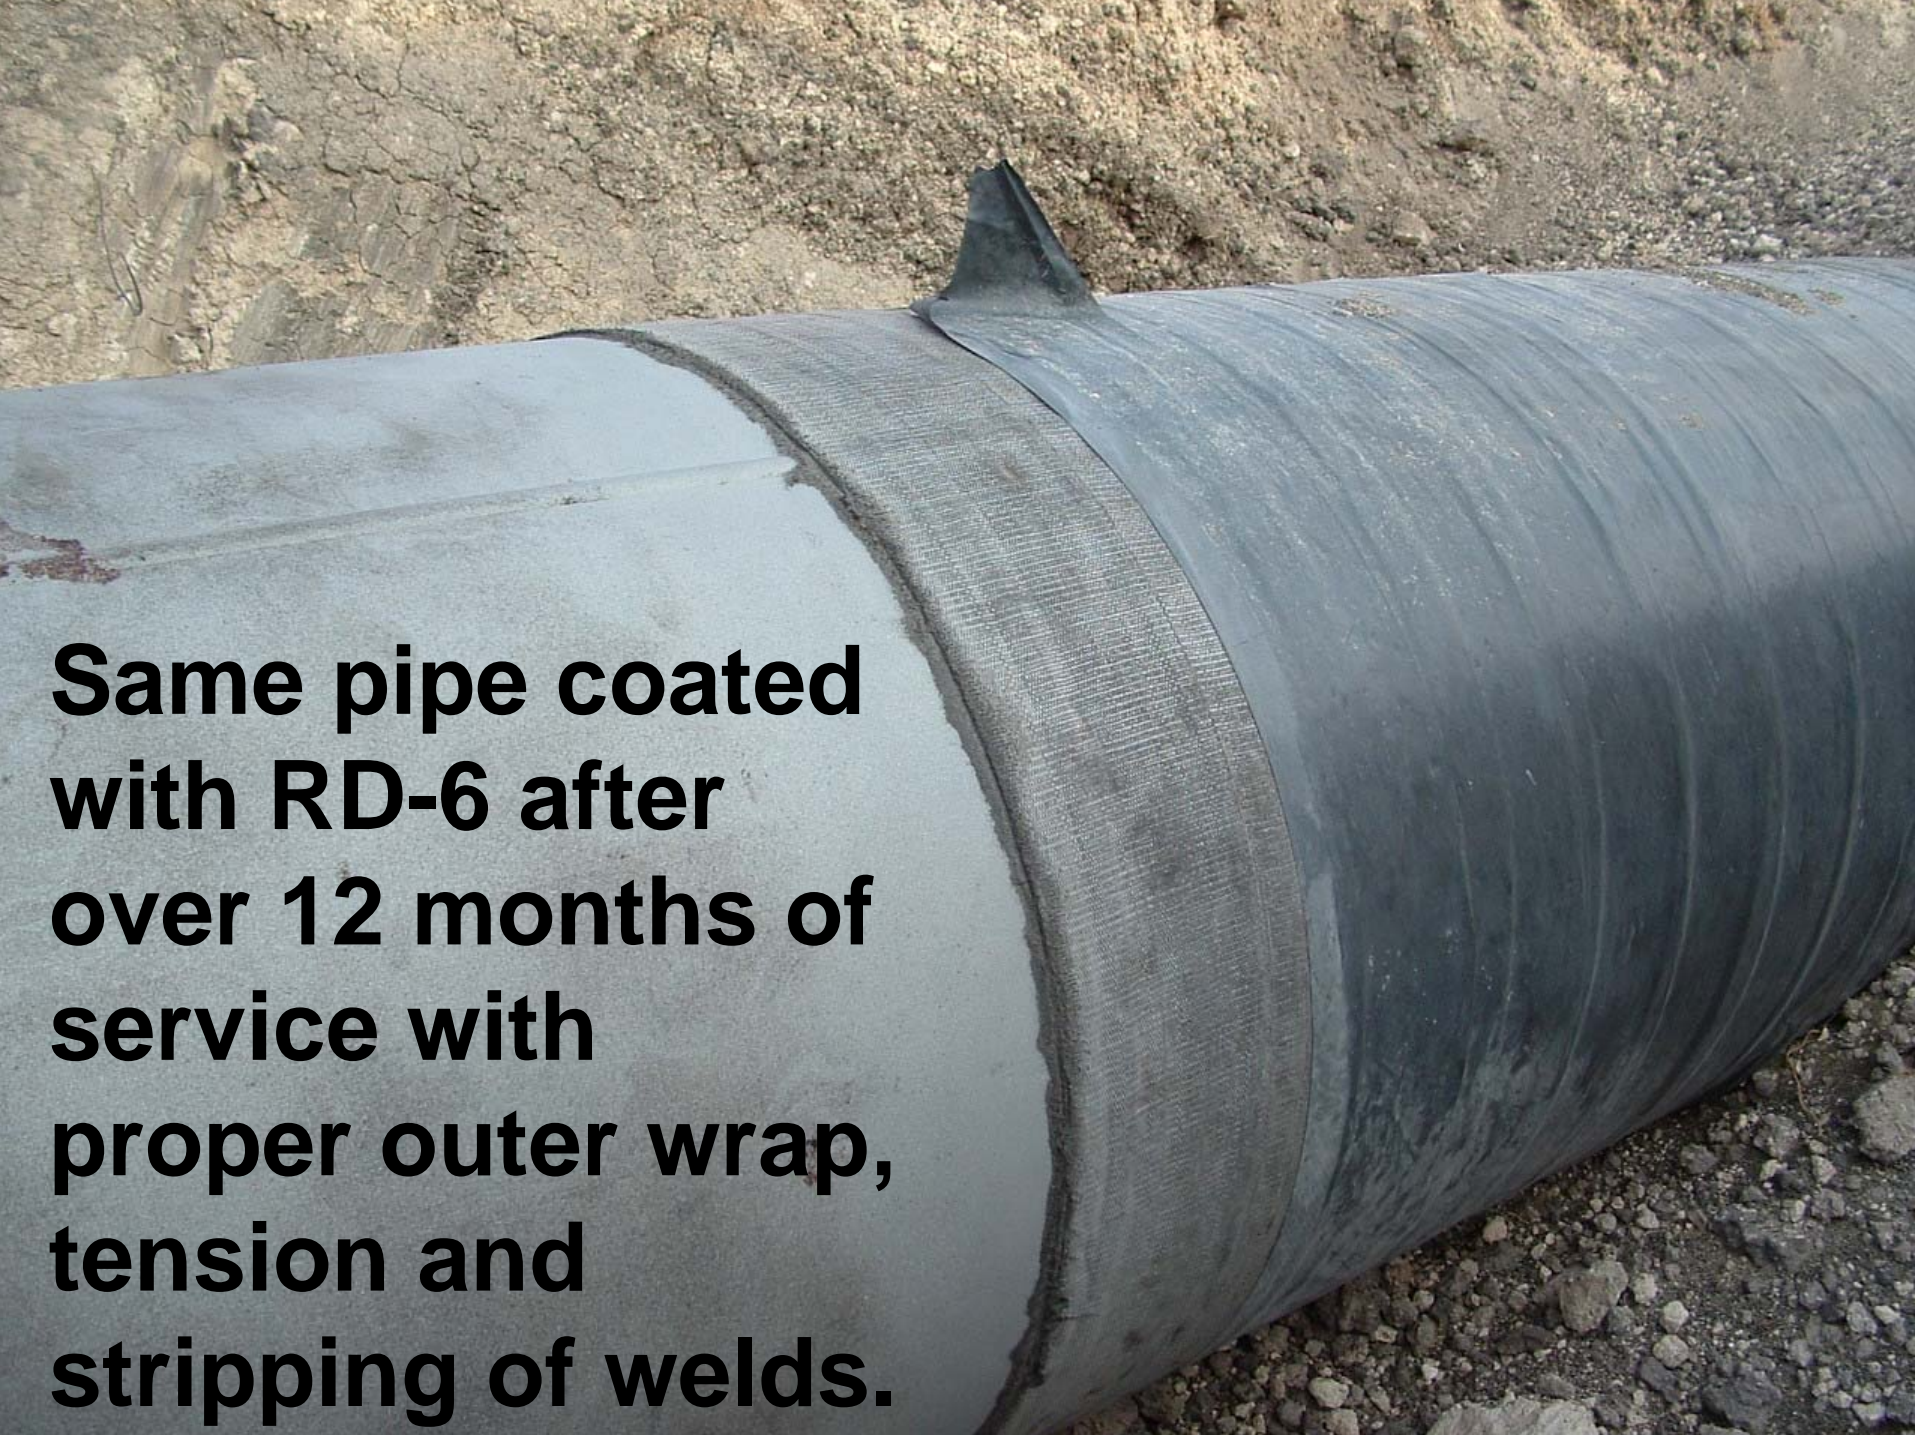
**Same pipe coated  
with RD-6 after  
over 12 months of  
service with  
proper outer wrap,  
tension and  
stripping of welds.**

Next slide shows properly applied RD-6 in the same area after one year.

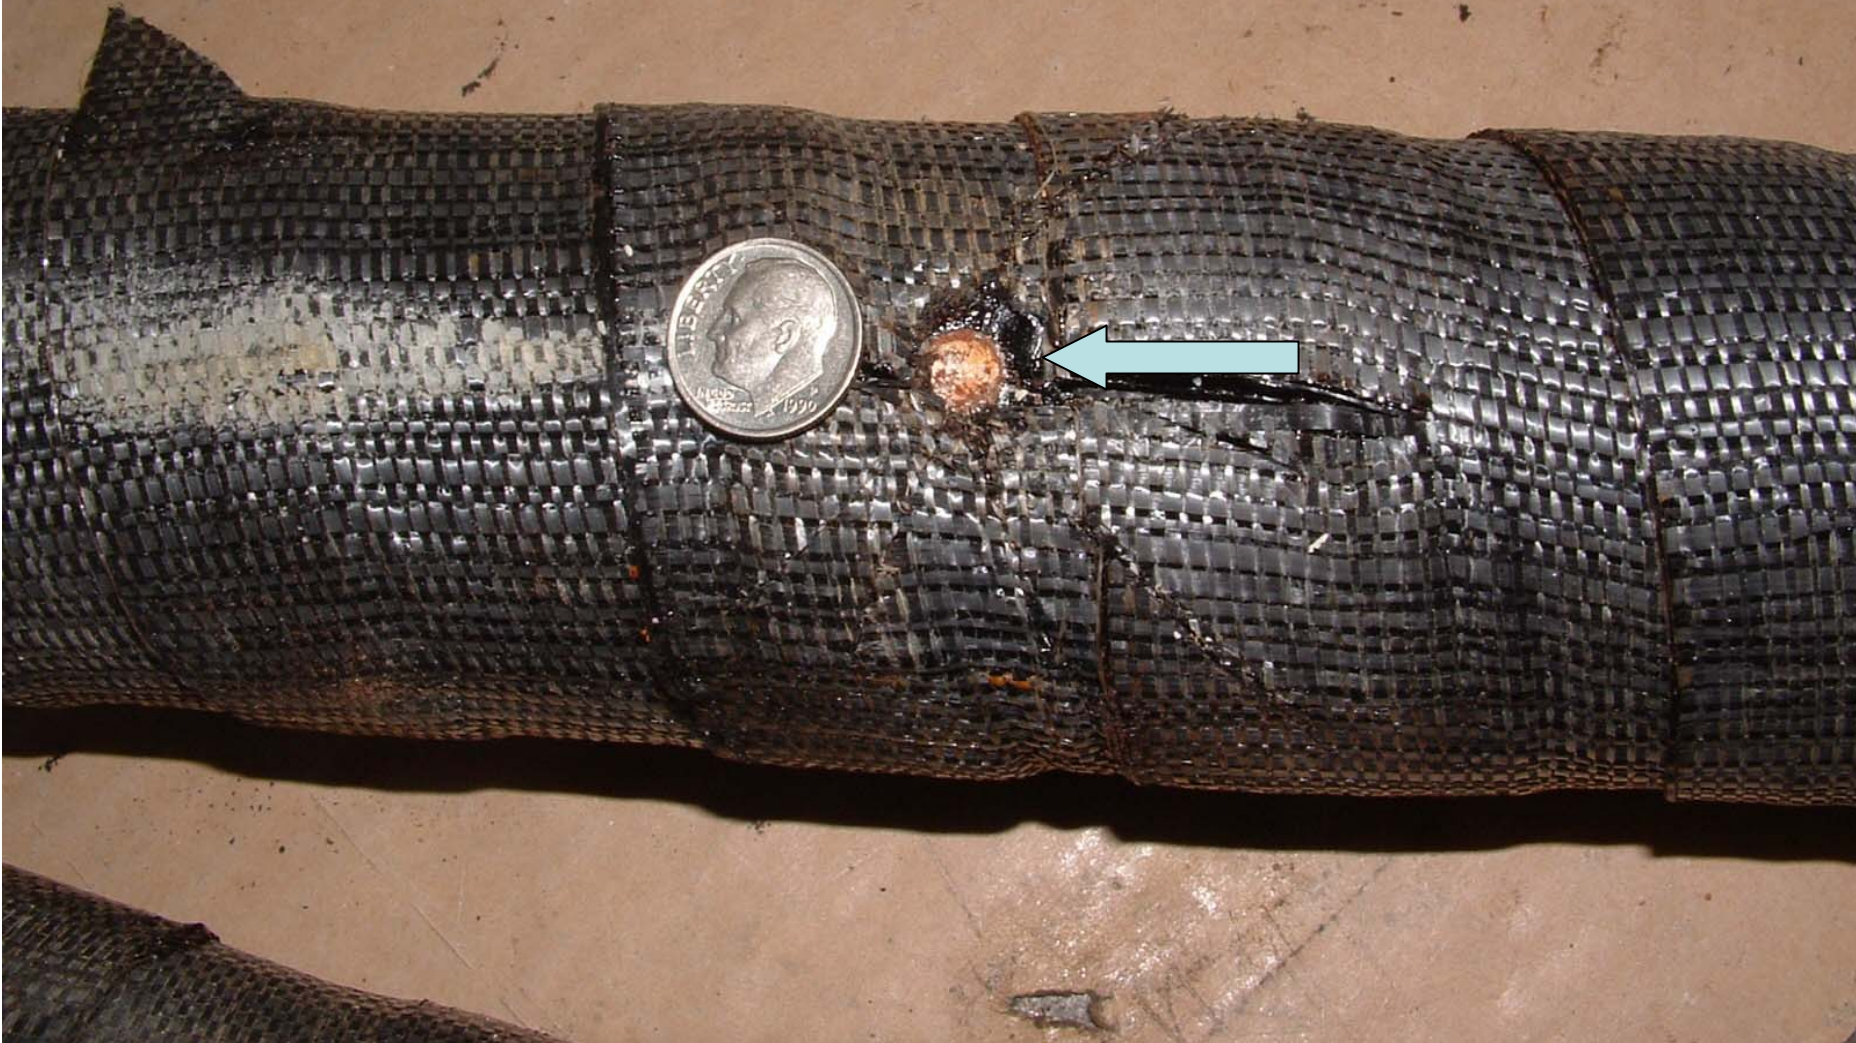
Thirty day cathodic disbondment test [CDT] on RD-6 (1.5 V & 72° F). Typical CDT results are 0 to 8 mm of disbondment.

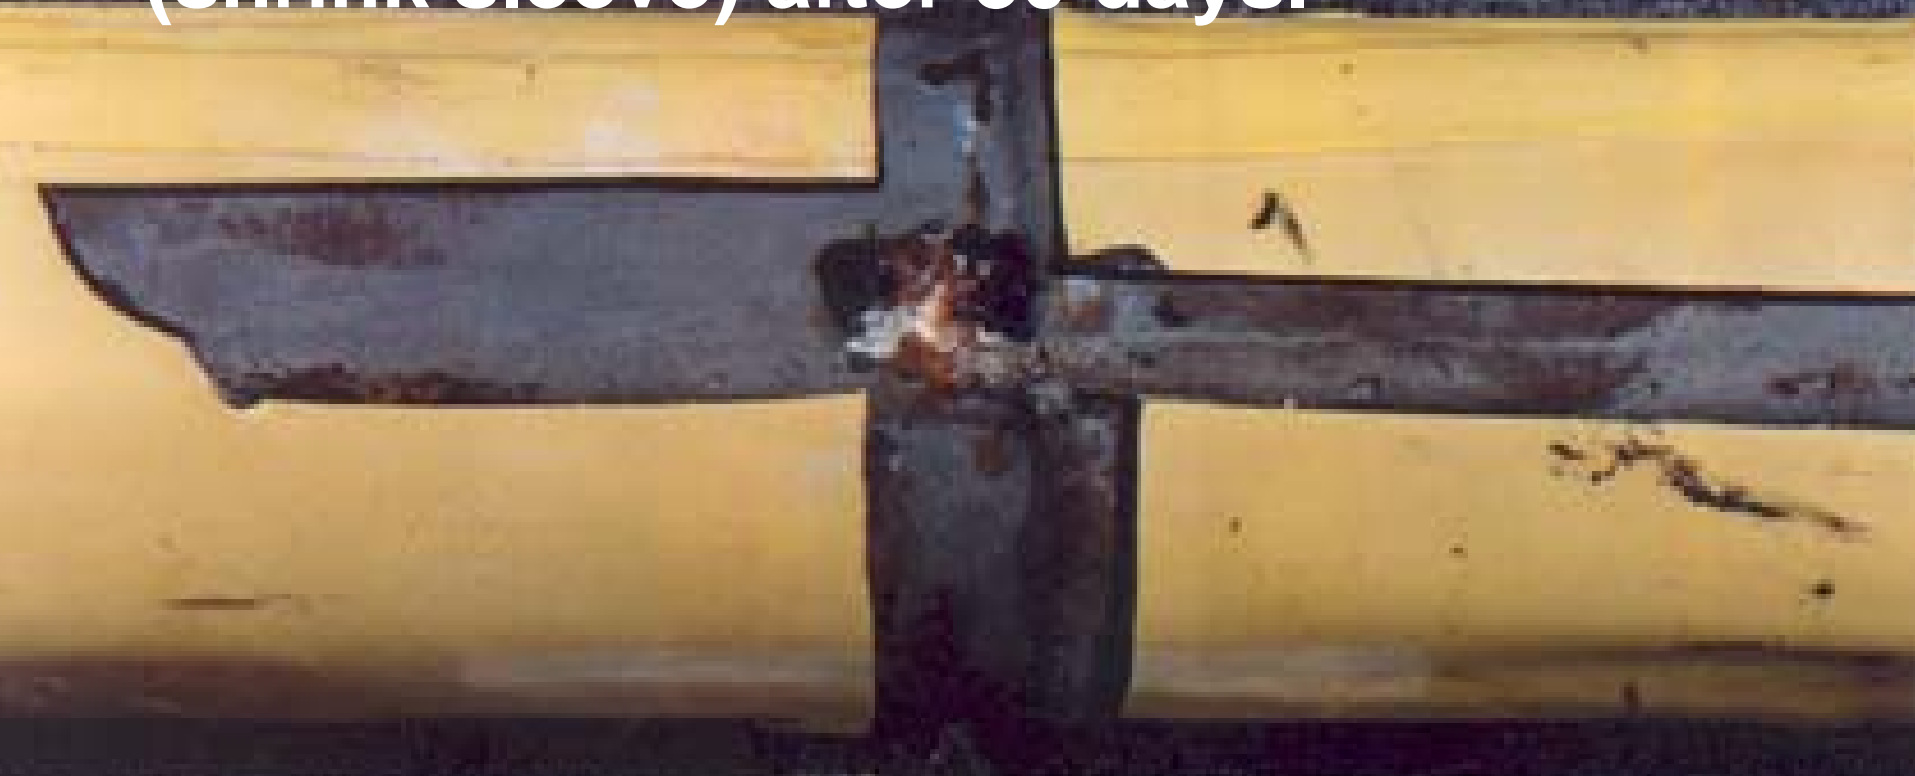
# Failed cathodic disbondment test result (shrink sleeve) after 30 days.

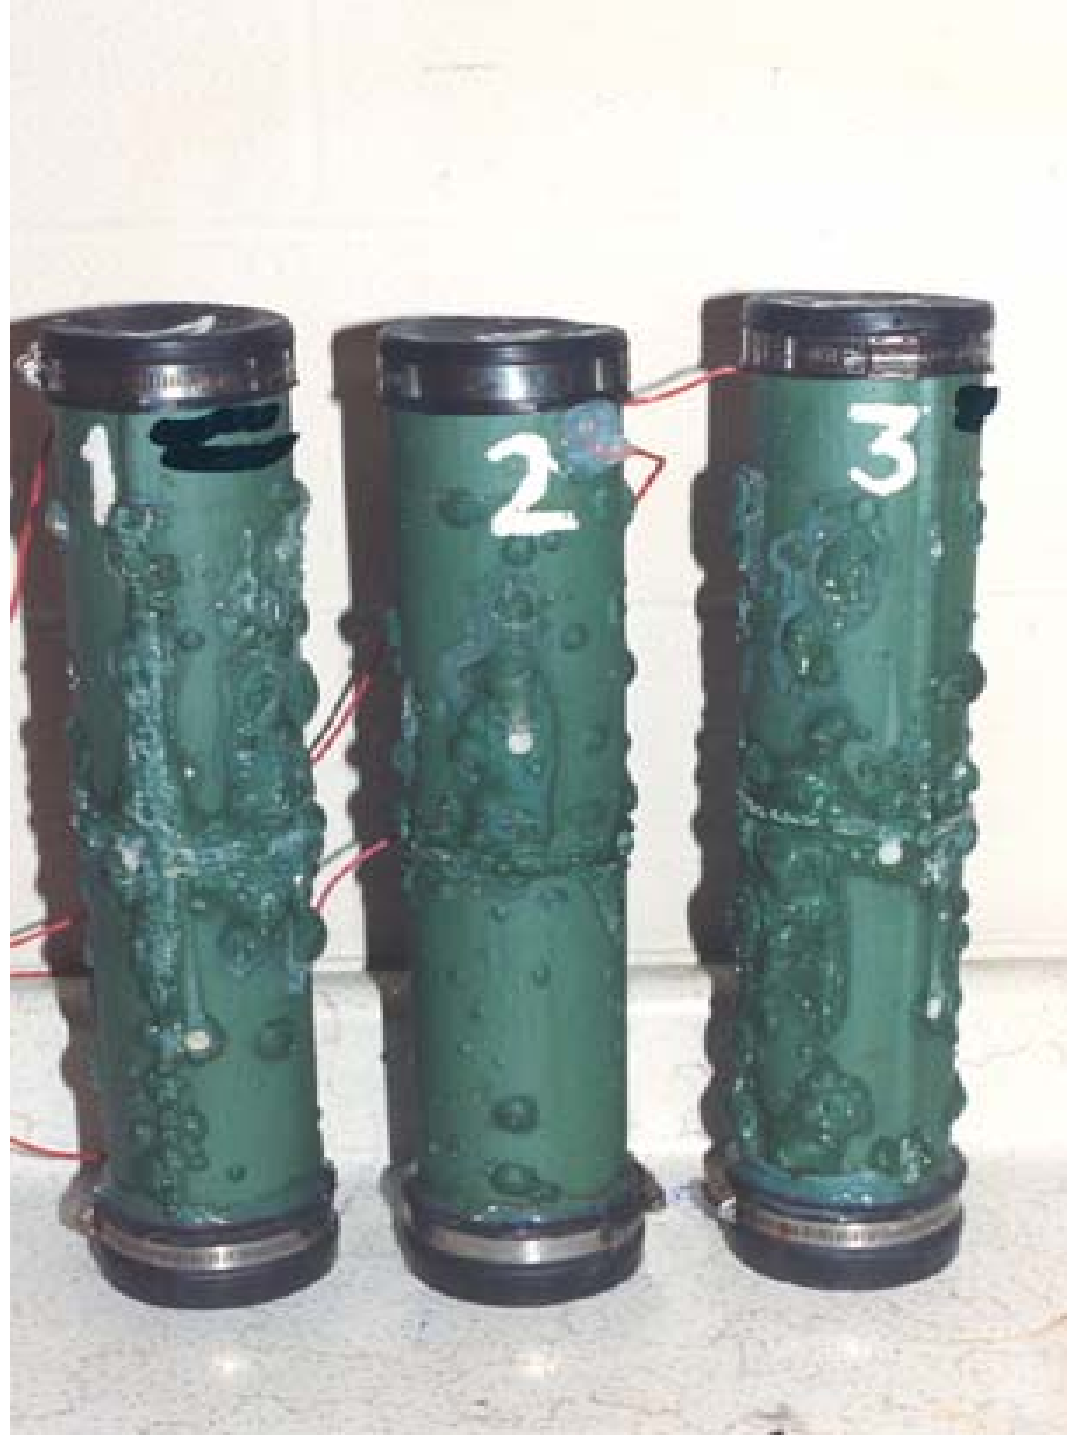
Test System No. 10  
[REDACTED]

Cathodic Disbondment  
30 Days

Failure after 3  
days in CDT.  
(Moisture cured  
urethane)

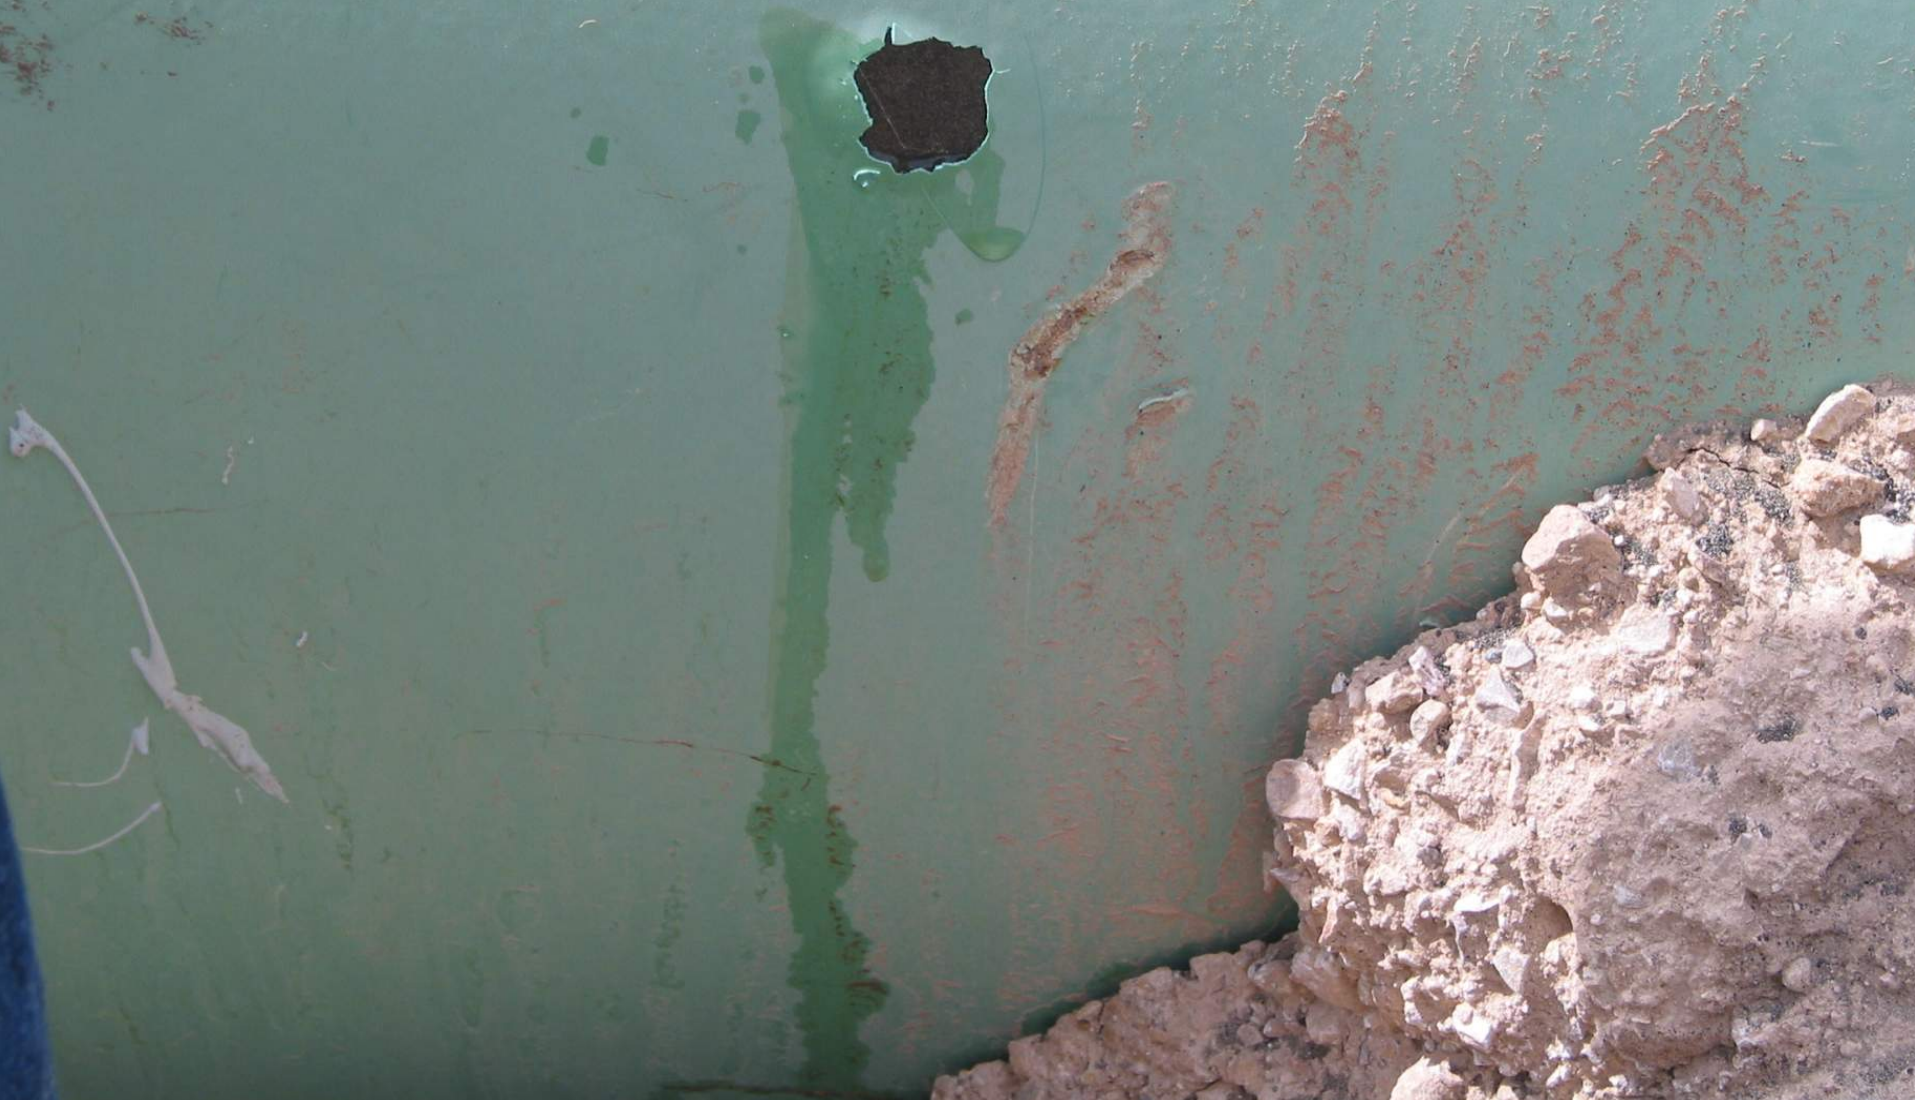
Water under blisters on FBE coated pipe used for gas transmission in central USA. Water under the blisters had a Ph of 12.

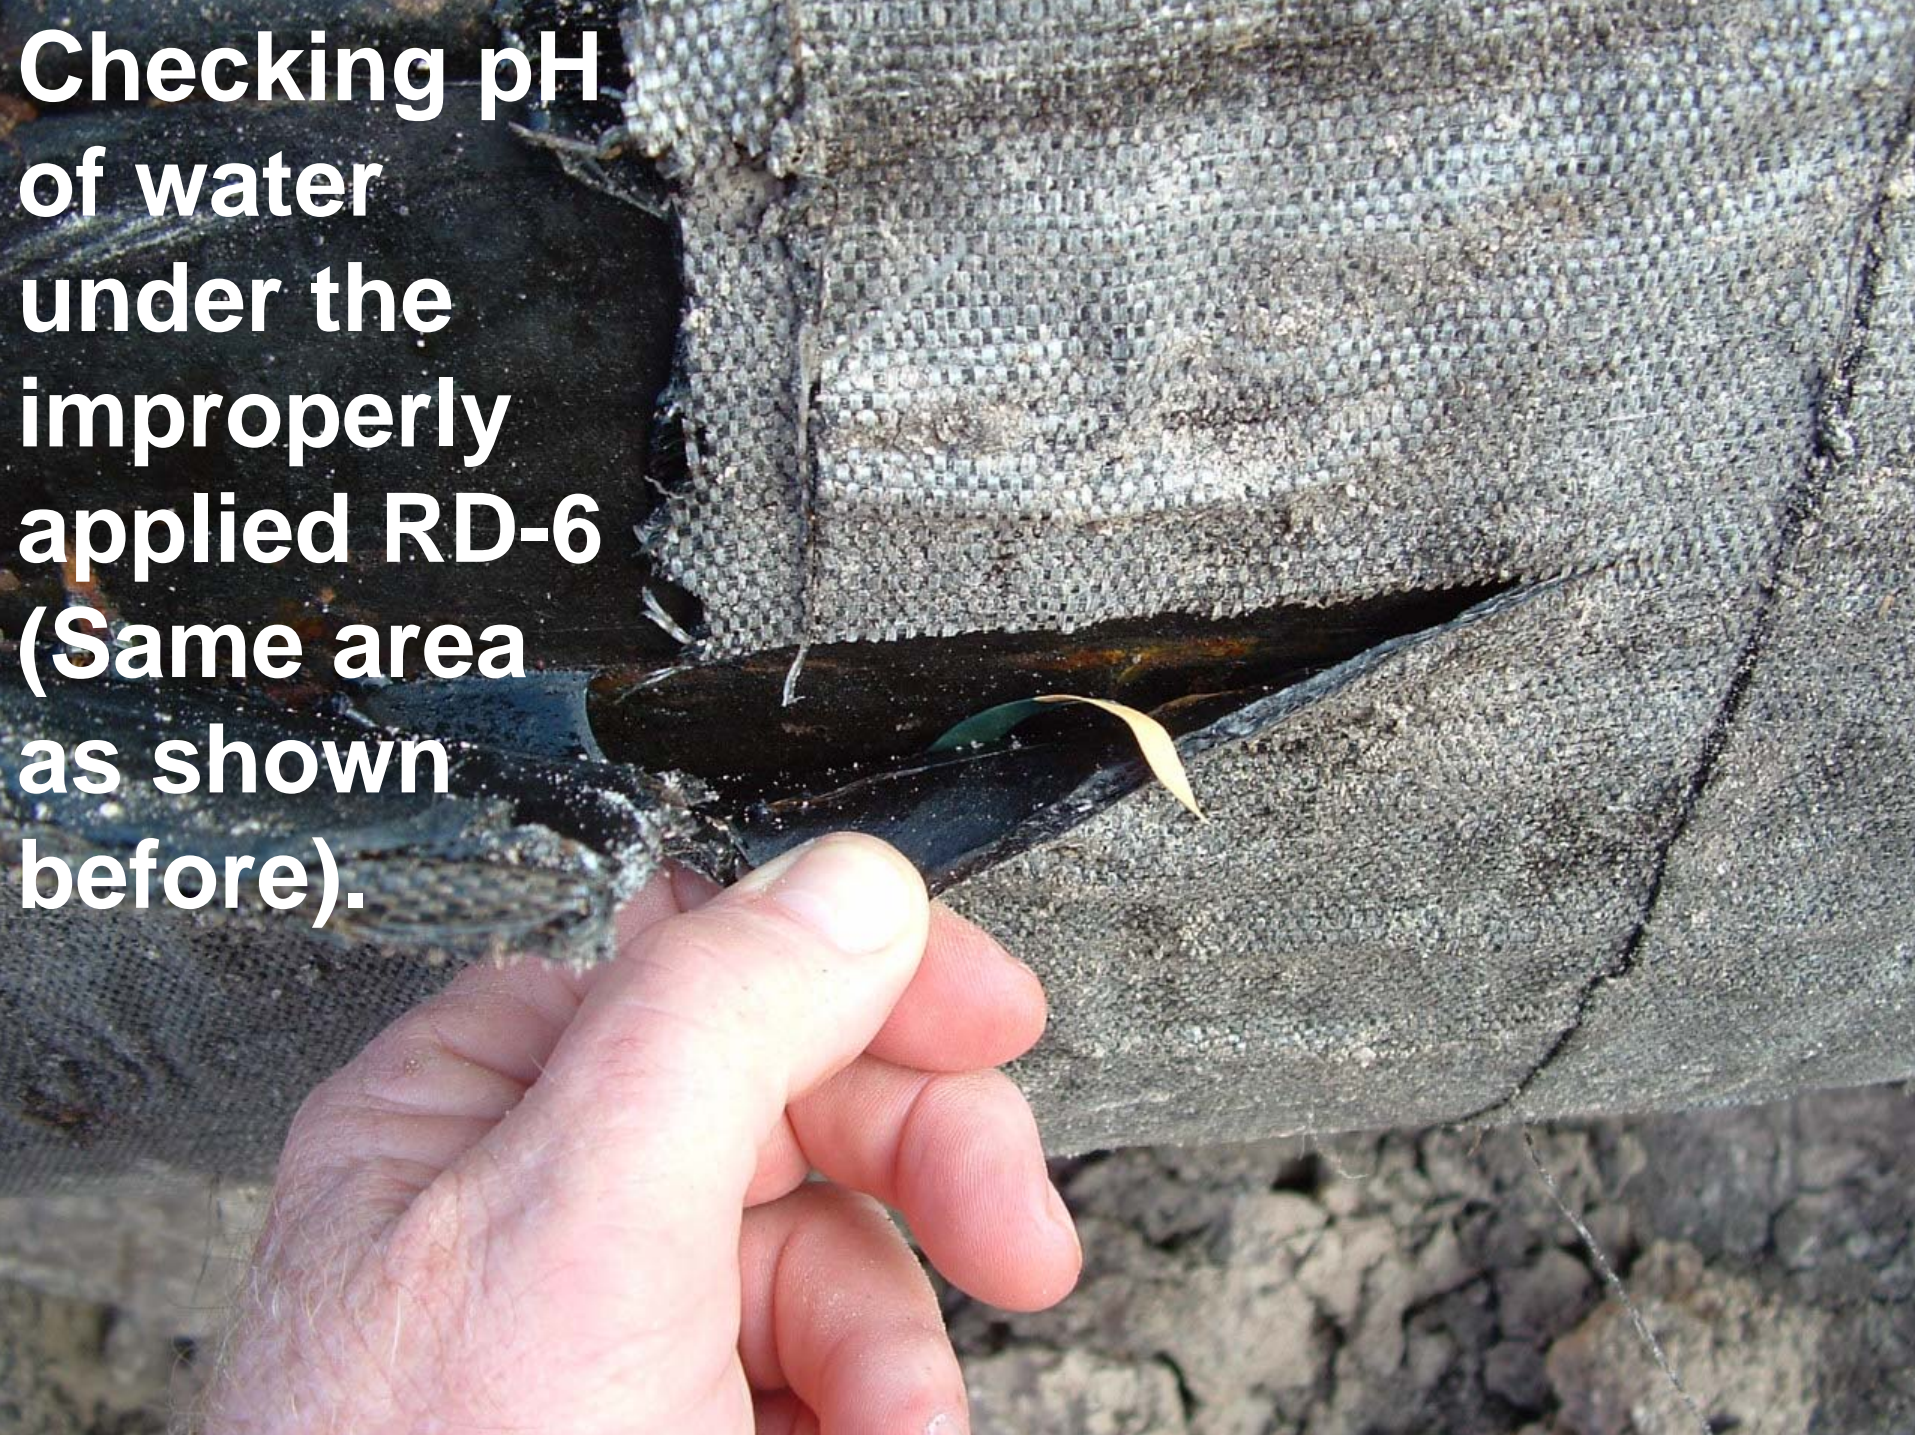
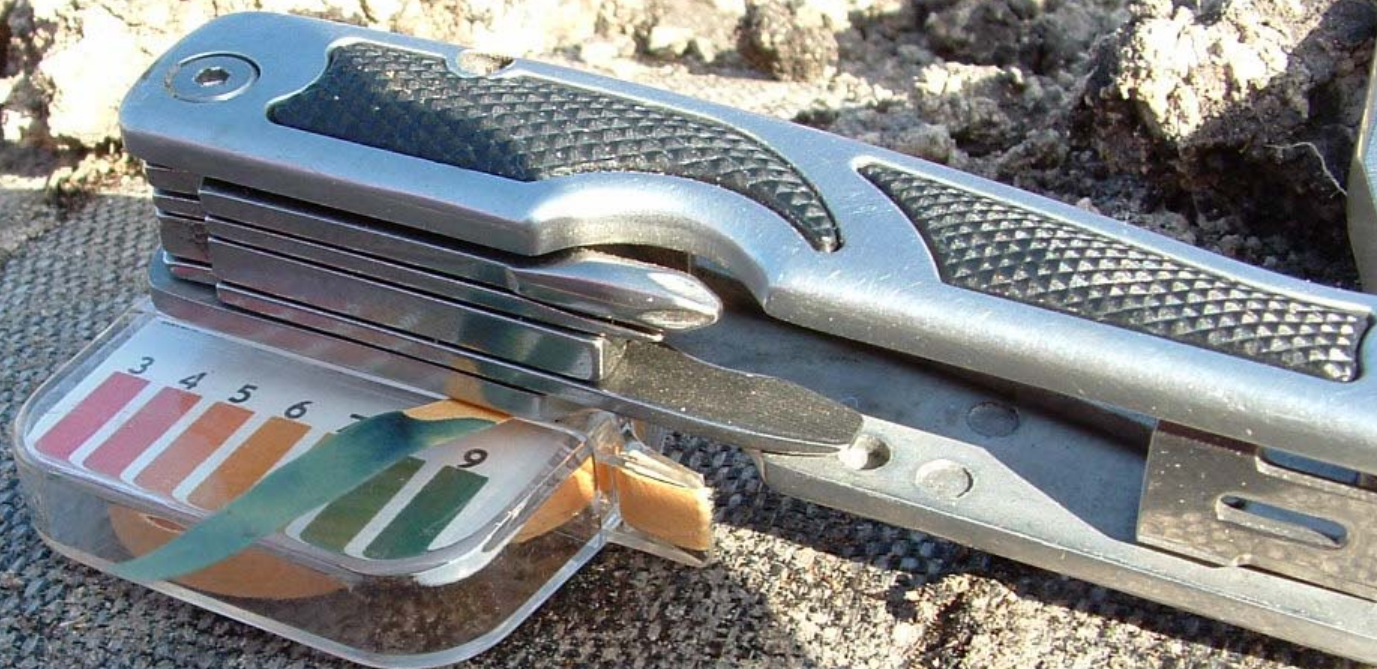
**Checking pH  
of water  
under the  
improperly  
applied RD-6  
(Same area  
as shown  
before).**

**pH check indicates a high pH (9 to 10) in water under the improperly applied RD-6 showing it is “Fail Safe”.**

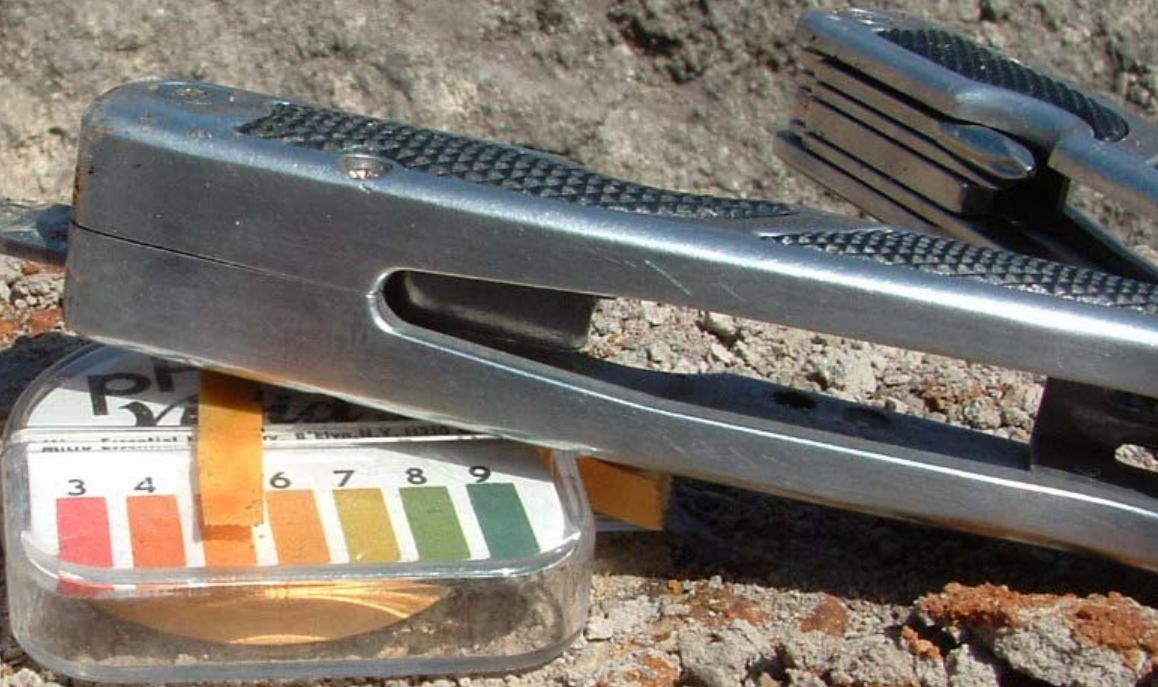
Checking pH  
under  
disbonded  
coal tar  
coating with  
significant  
corrosion  
present. This  
site is only a  
few feet from  
the previous  
slide.

pH of 5 to 6  
under  
disbonded  
coal tar  
coating.
