# POLYGUARD RD-6

**“A FAIL SAFE” PIPELINE**

**COATING SYSTEM**

**FOR REHABILITATION OR**

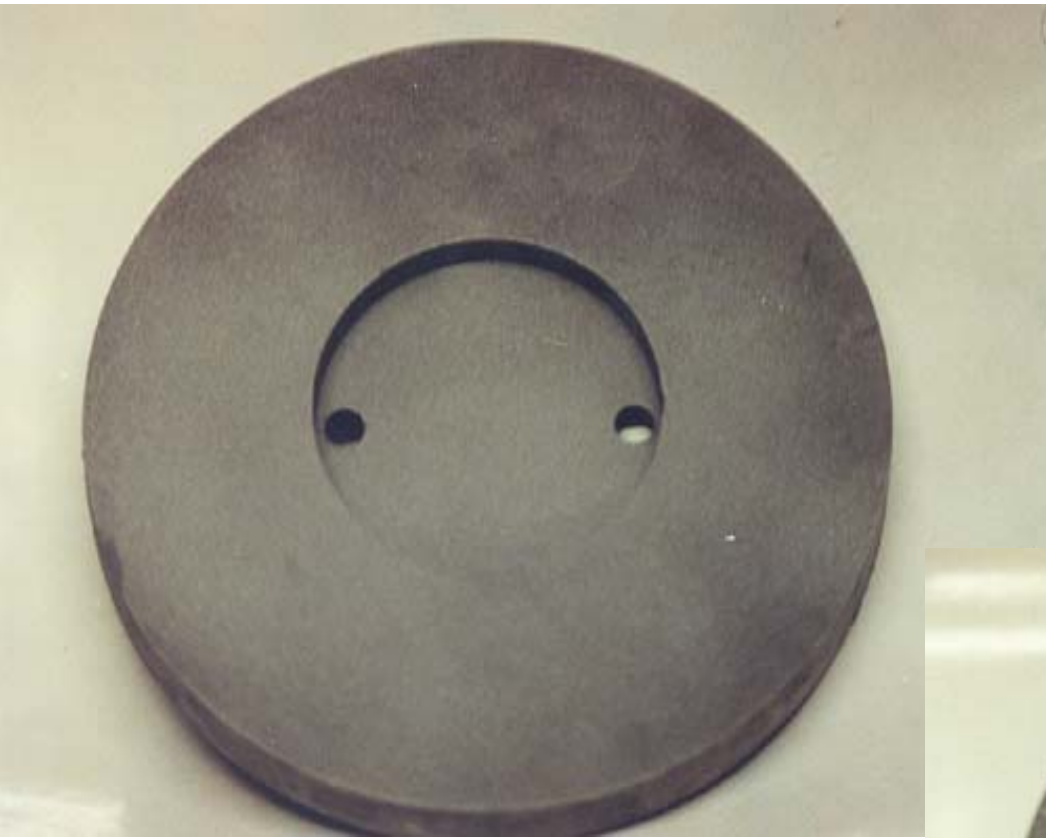
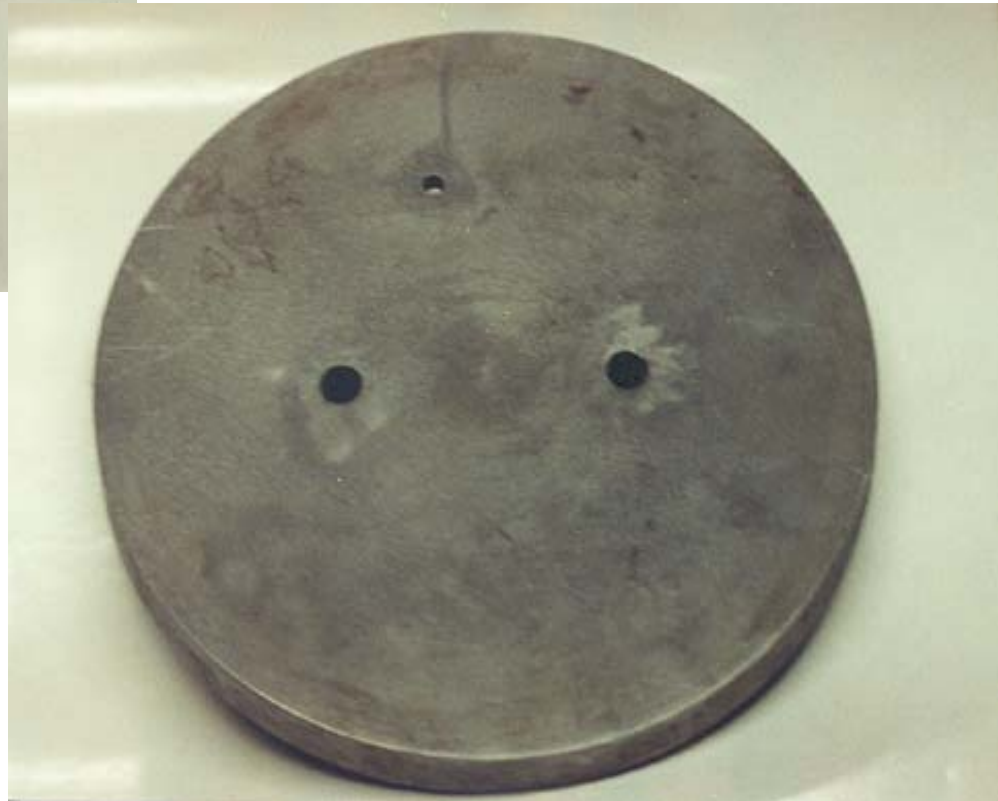
# Test jig for determining “Fail Safe” coatings

Disc is 0.5” thick,  
approximately 8” in  
diameter with a 3” x 0.25”  
machined area for “Fail  
Safe” void under coating.

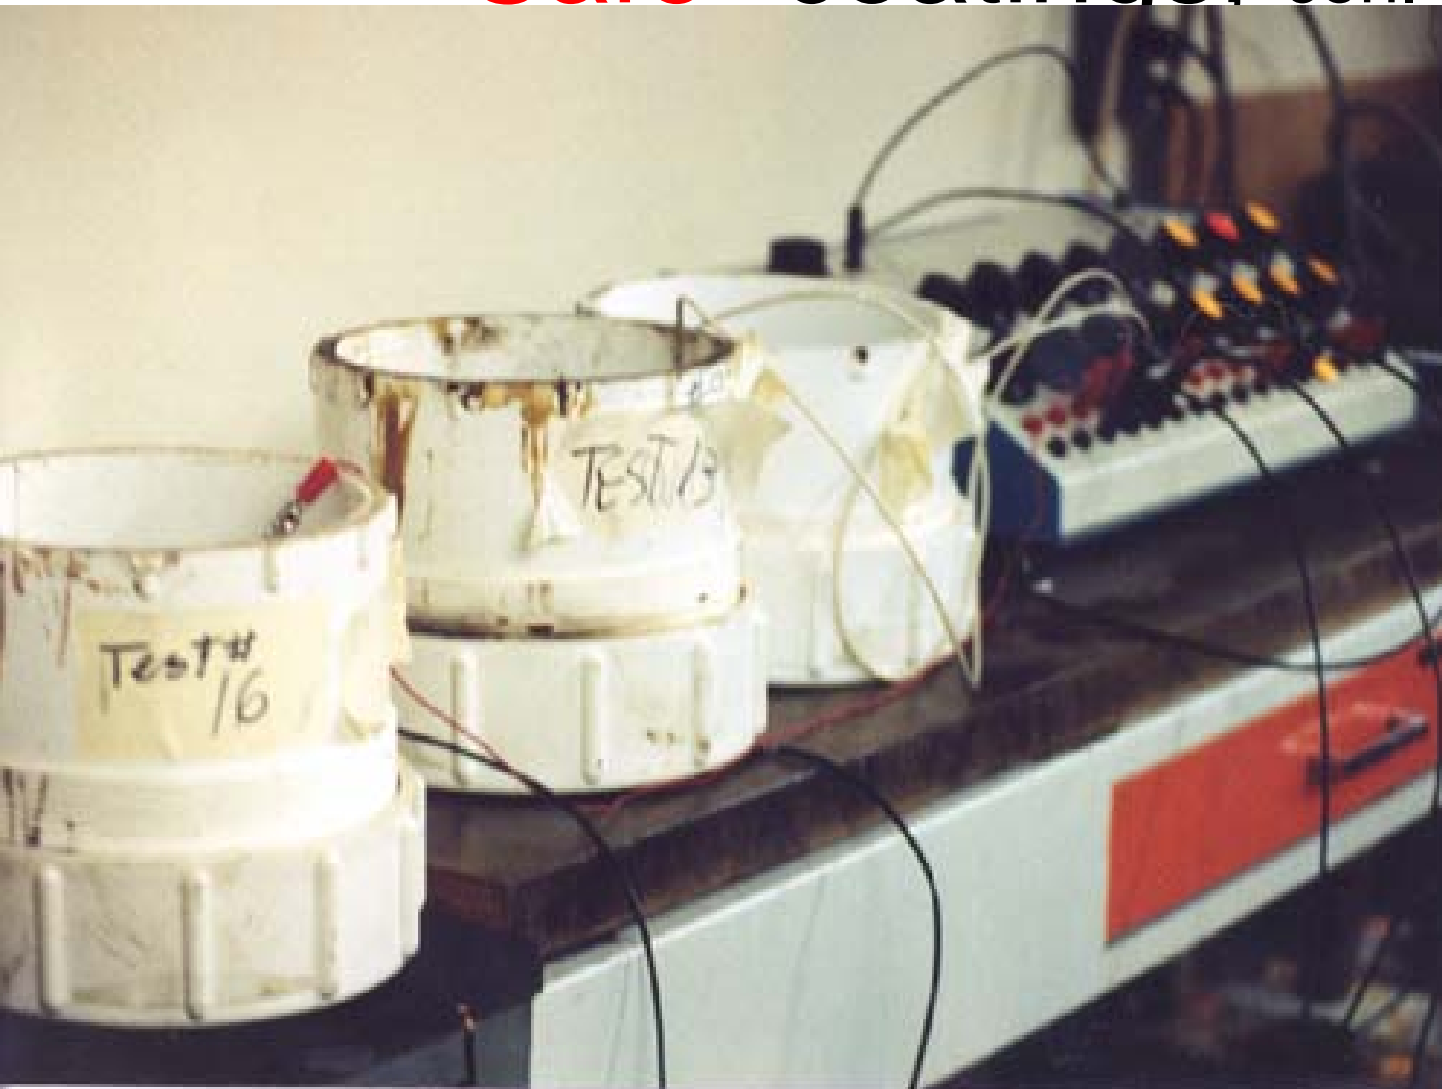
# Test jig for determining “Fail Safe” coatings, con.

Coating is applied over the disc with void. After sealing, water is placed on top of the coating and a anode is placed in this water. Negative return is attached to the bottom plate. 1.5 to 3 volts is applied for two weeks.

- Typically, if the coating is not “fail safe”, the pH of the water in the void will change less than one pH value either way.
- With a “fail safe” coating the pH of the water will typically change to between 9 and 13.
- Repeated testing is required to help eliminate possible errors.
- Test jigs may have to be adapted slightly for certain coating types.
